APPENDIX D –

RIVER OBSTRUCTION INSPECTION PHOTOS

River Obstructions

Section 1: Howell Highway to Island Park

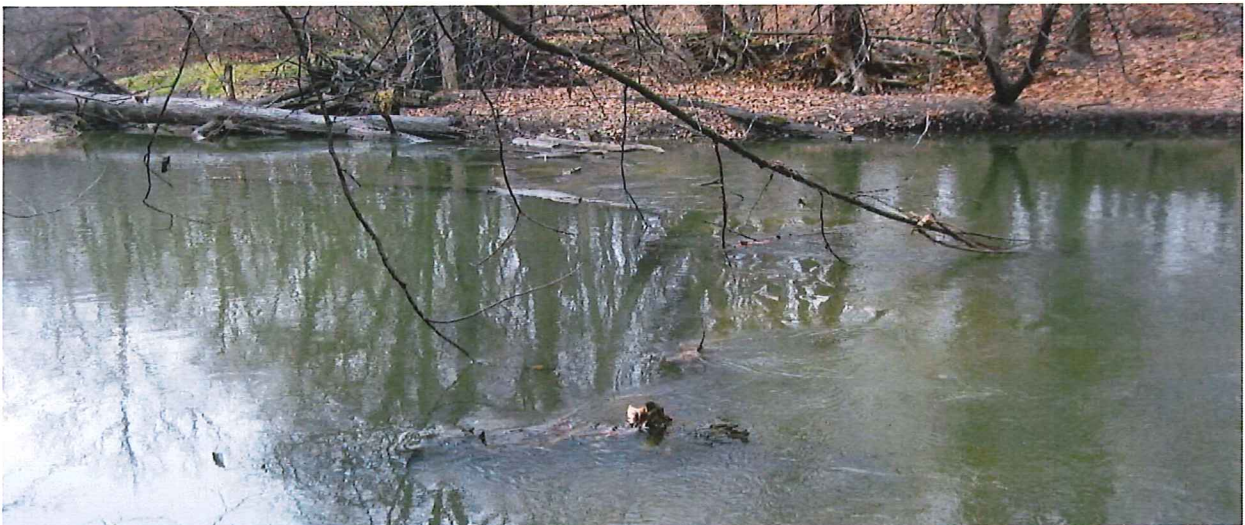
Photo 1 (Section 1 - south bank looking north): Two partly submerged 5" diameter logs cross from one side of the river to the other

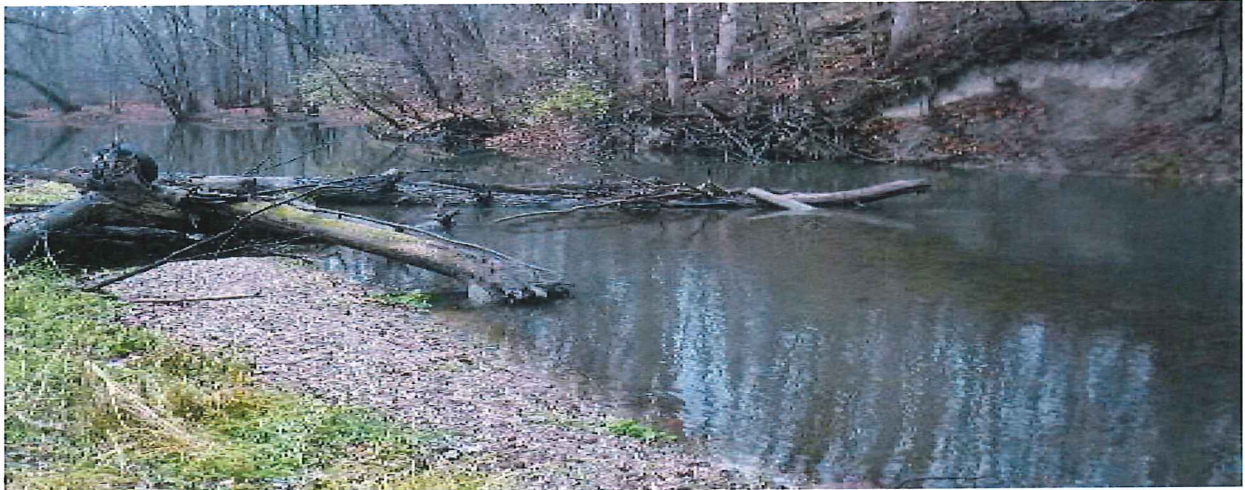
Photo 5 (Section 1 - south bank looking upstream): 8" Down tree partially blocking passage for kayakers

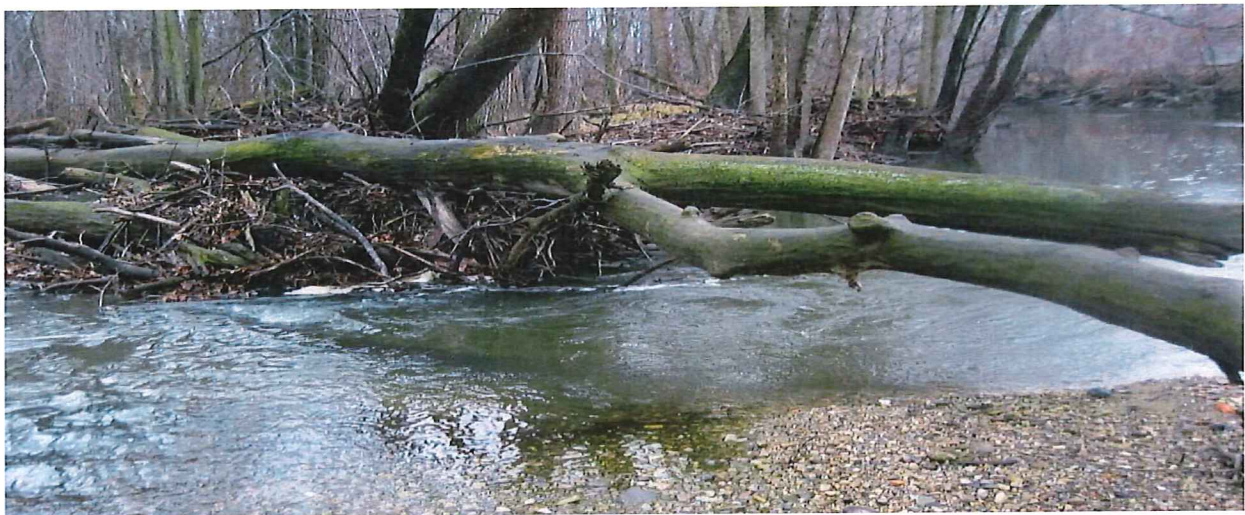
Photo 6 (Section 1 - south bank looking downstream): Foot-diameter tree and a pile of branches blocking potential path of kayak

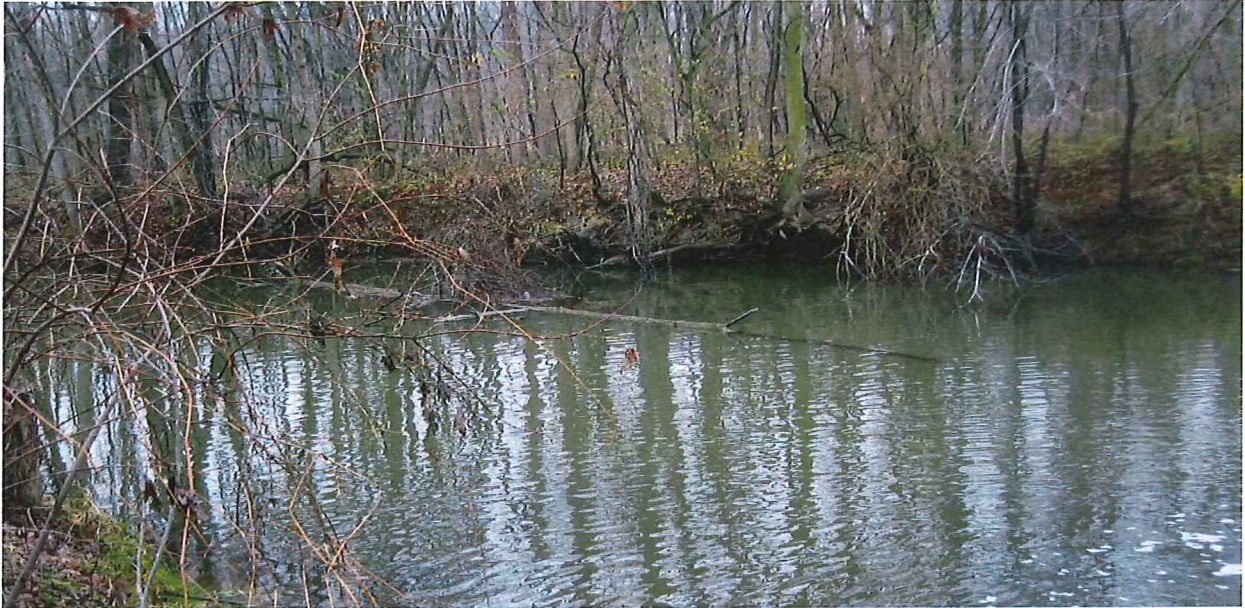
Photo 7 (Section 1 – south bank looking upstream): Floating tree in river with overhanging branches that impede flow

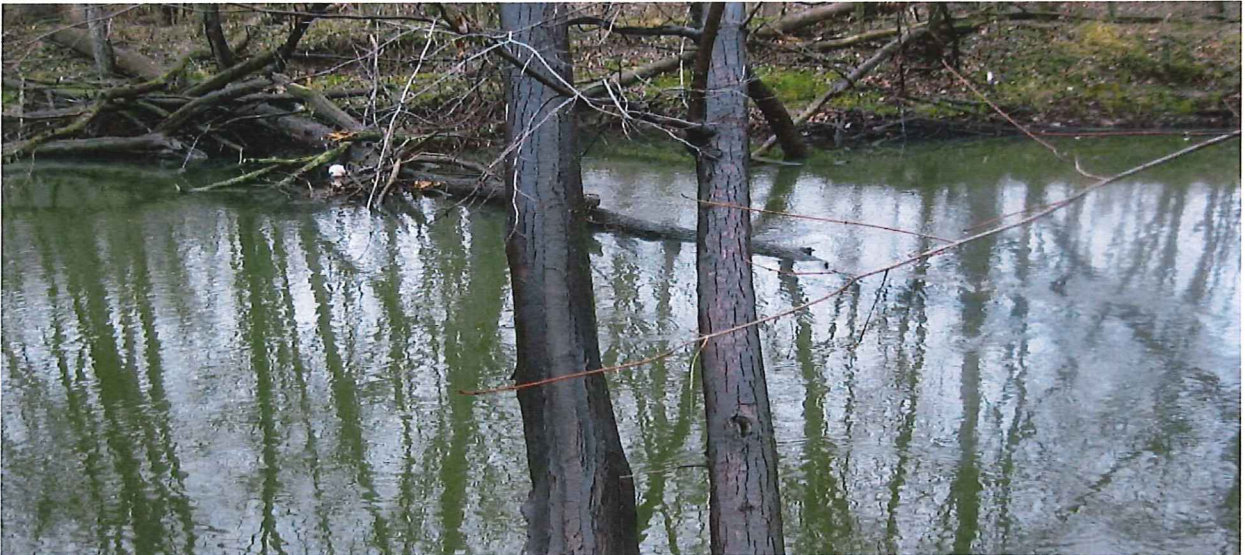
Photo 8 (Section 1 – south bank looking opposite side of river): Down tree blocking over half of river

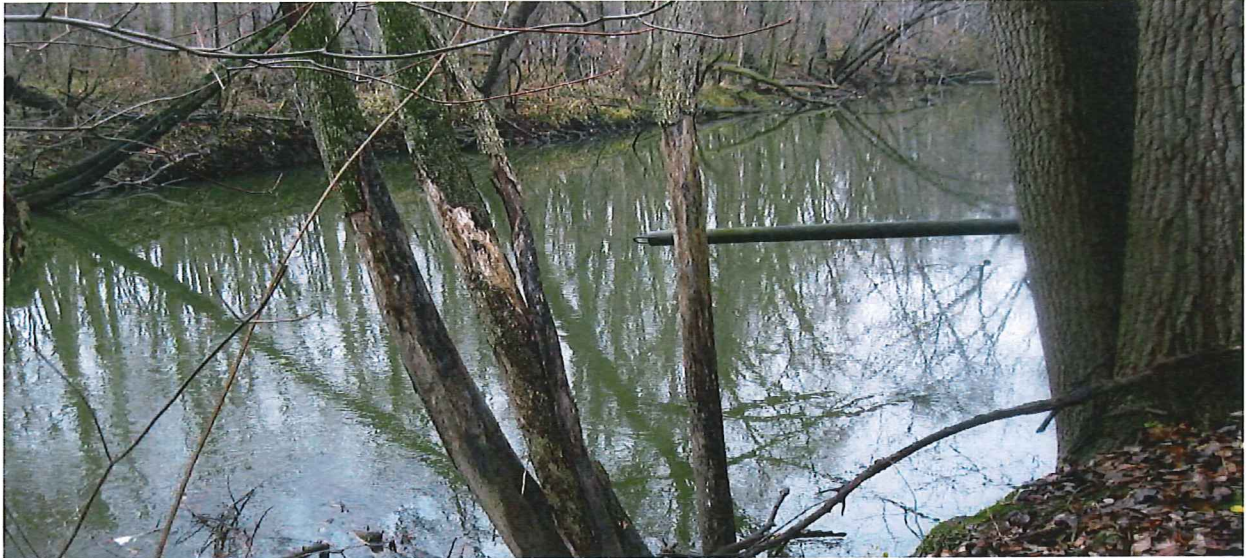
Photo 9 (Section 1 – south bank looking downstream): Pipe from treatment plant overhanging over part of river

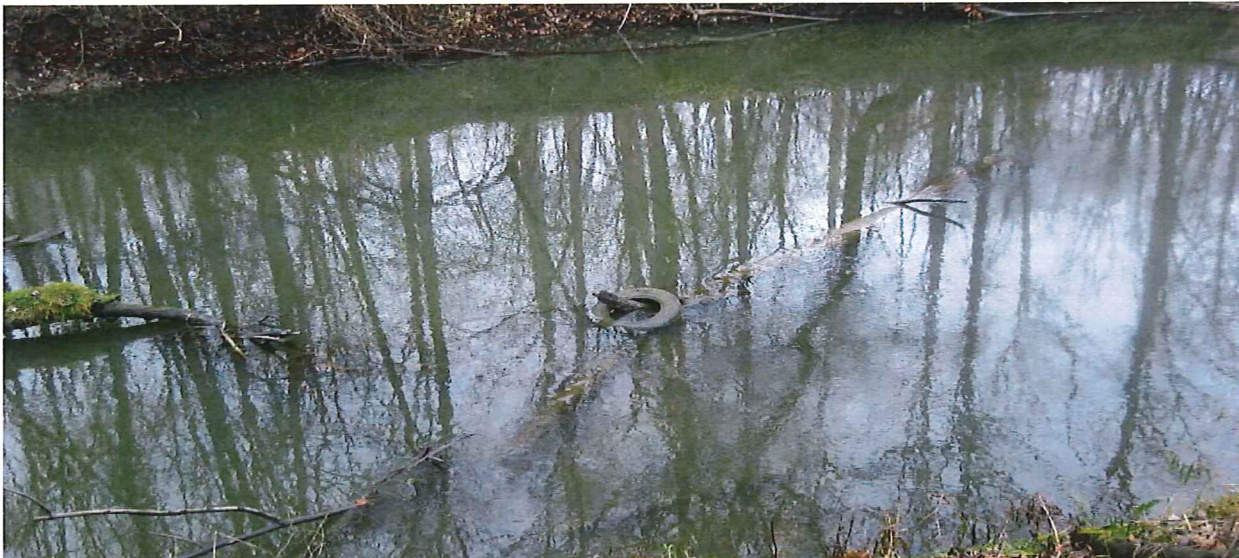
Photo 12 (Section 1 - south bank looking downstream): Tree submerged near southern bank of river

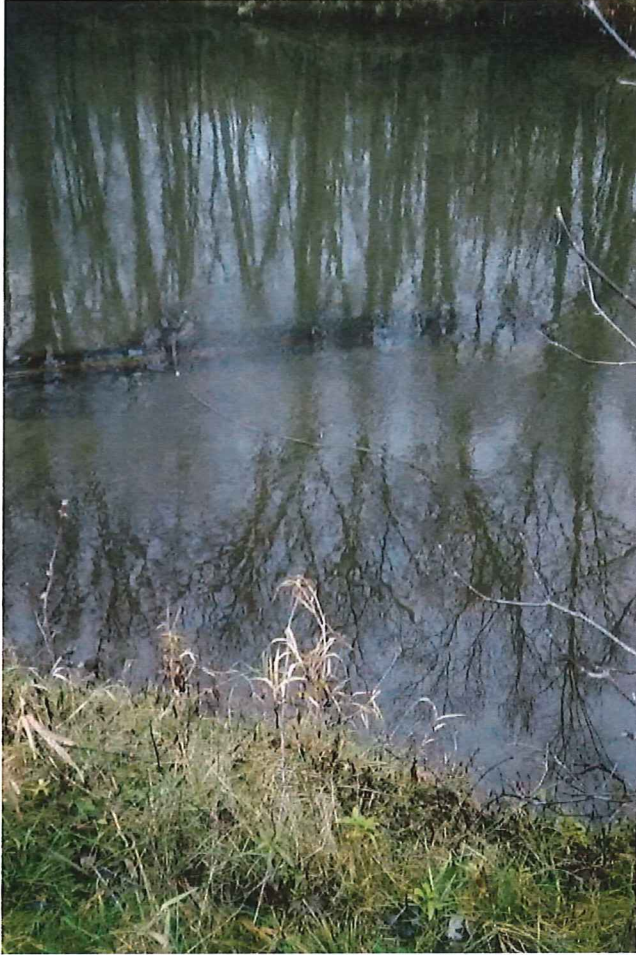
Photo 19 (Section 1 – south bank looking upstream):
Waterlogged tree in river possibly impeding kayak path

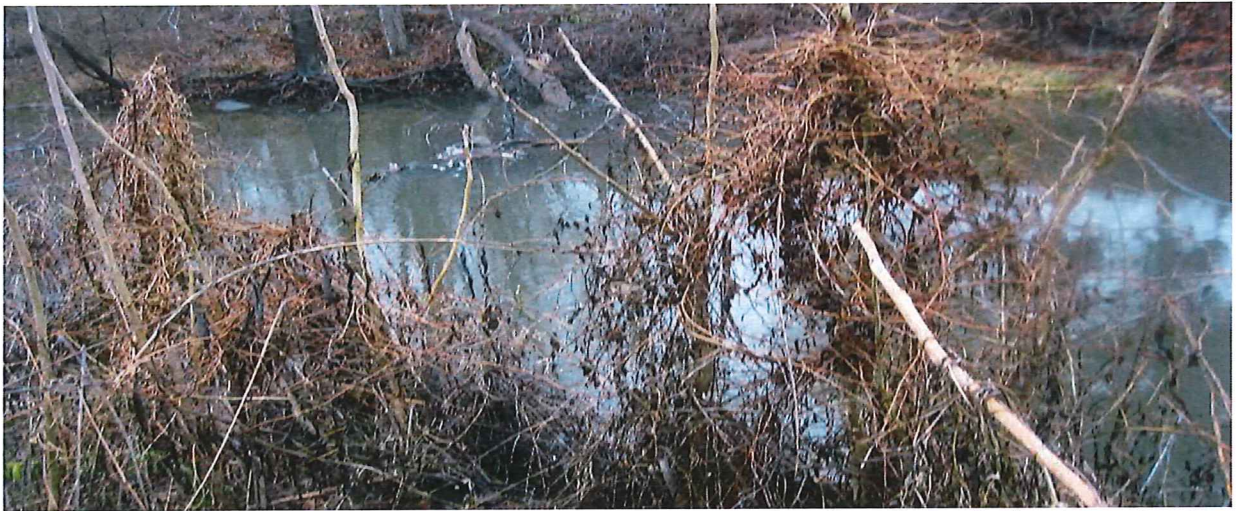
Photo 30 (Section 2 – south bank looking upstream): Three boulders and a tree creating obstacle for river navigation

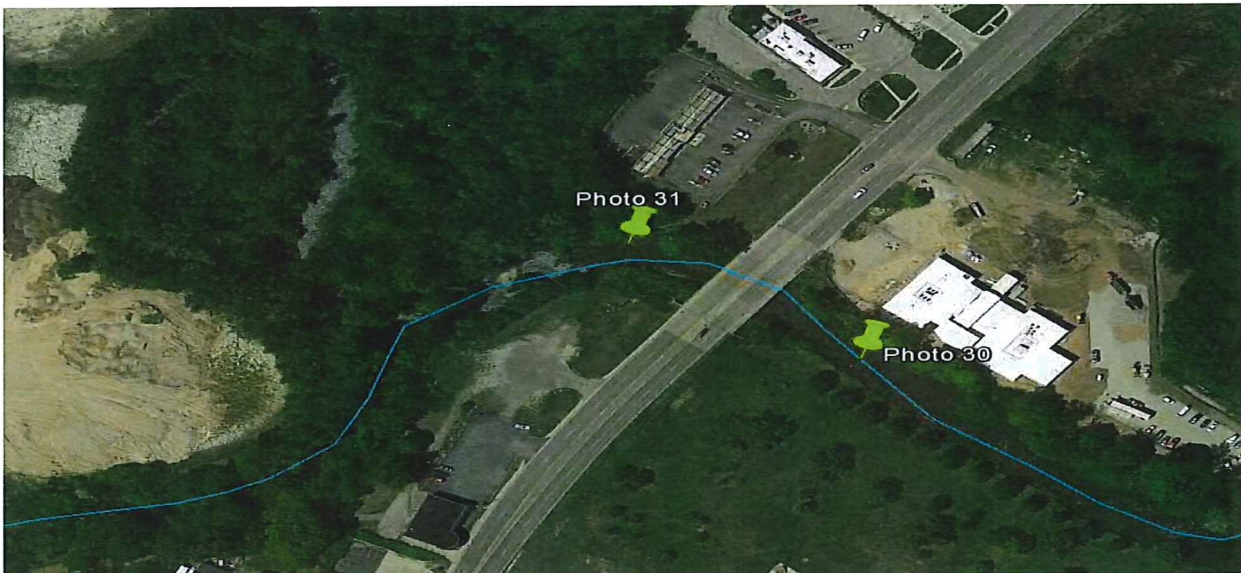
Photo 31 (Section 2 – south bank looking north): Tree floating off of north bank creating navigational hazard on river

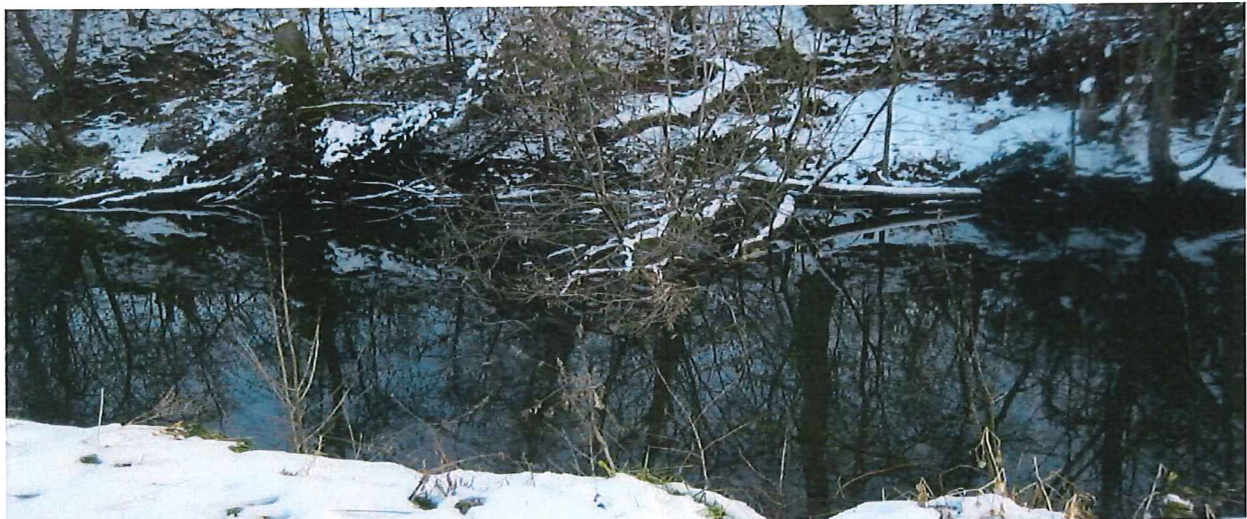
Photo 52 (Section 4 – west bank looking across river): Tree overhanging river on the east bank

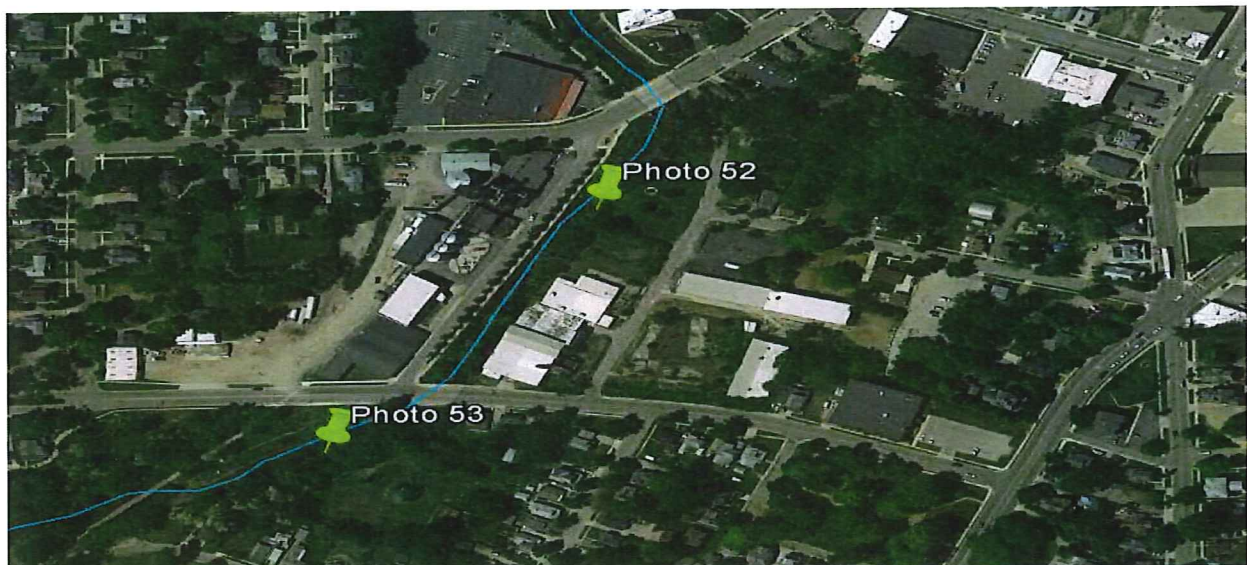
Photo 53 (Section 4 – west bank looking across river): Overhanging tree hanging over river near Michigan Avenue Bridge

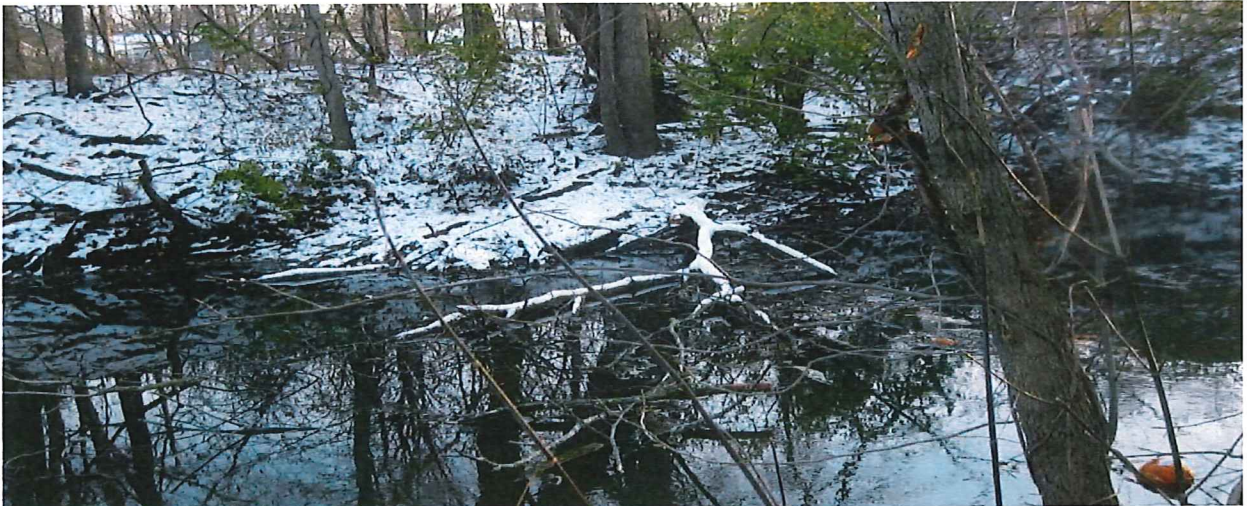
Photo 54 (Section 4 – north bank looking downstream): Piles of branches blocking passage by Kiwanis bridge)

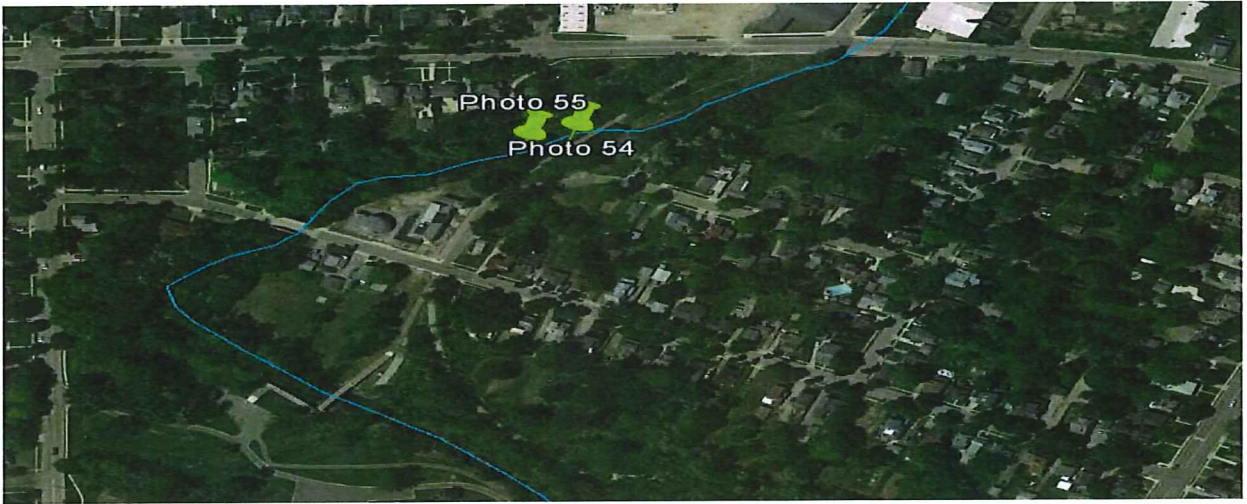
Photo 55 (Section 4 – north bank looking across river): Downed tree blocking passage through river

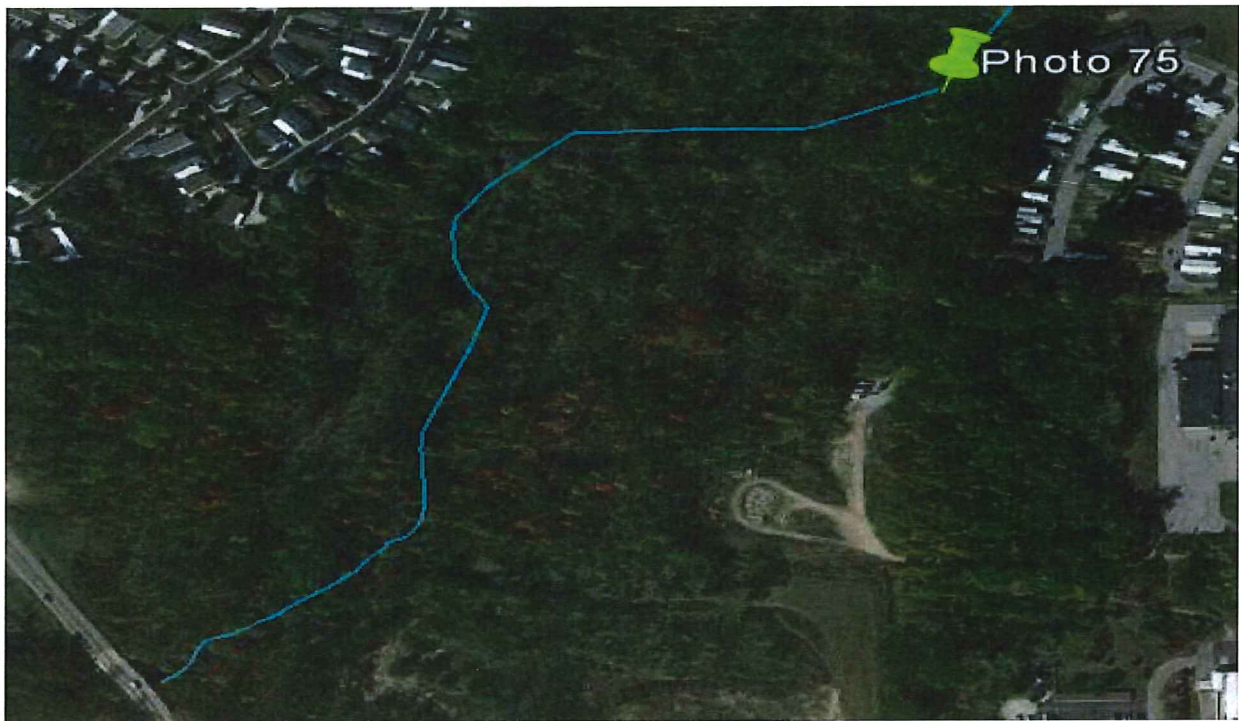
Photo 75 (Section 5 – east bank looking downstream): Large (2-foot diameter) tree resting over river

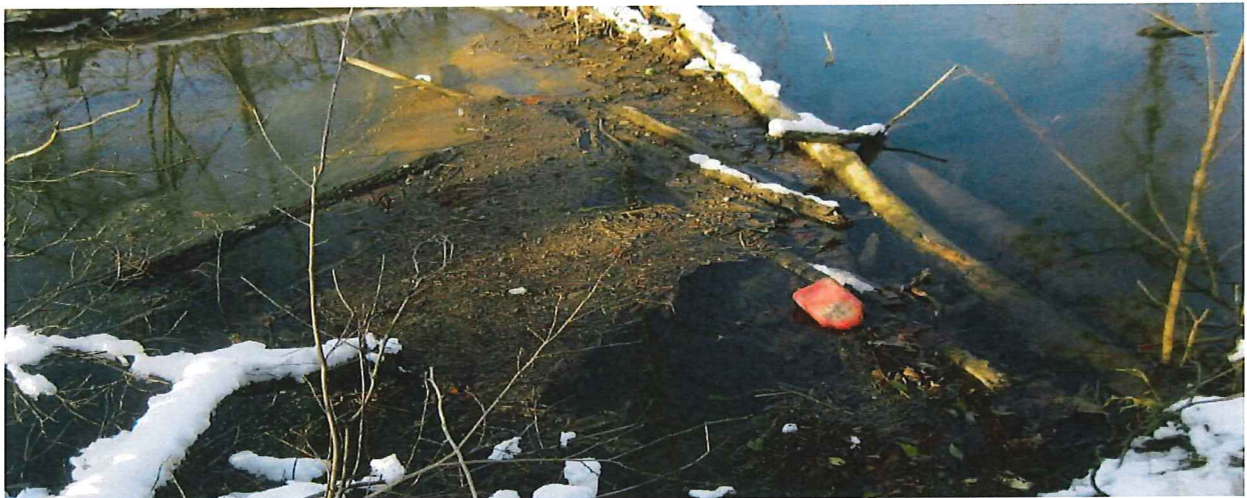
Photo 76 (Section 5 – south bank looking downstream): Trees blocking both banks of river with a small area in the middle for passage

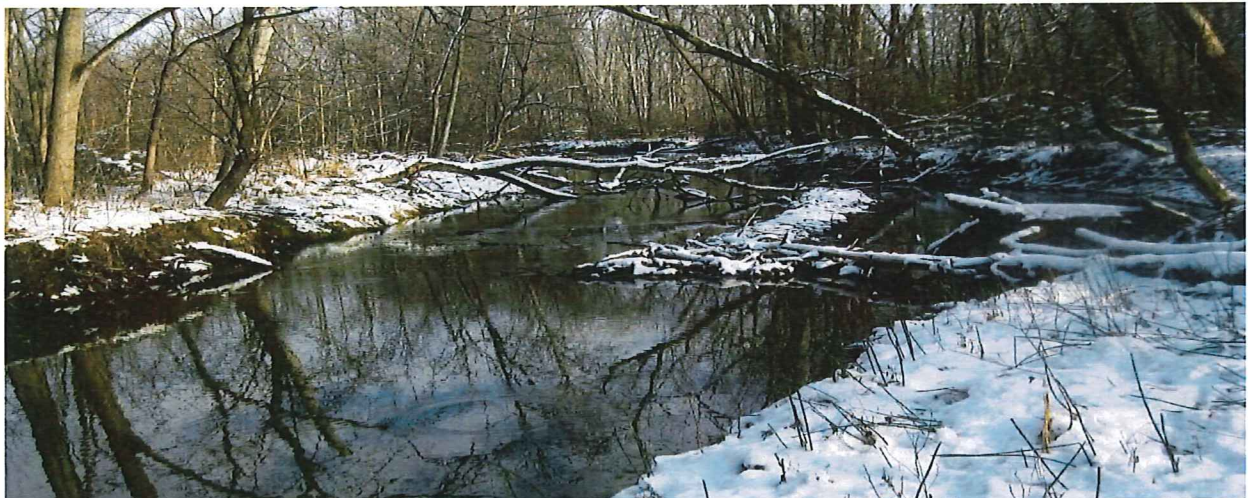
Photo 78 (Section 5 – south bank looking across river): Trees creating obstacles on both sides of river

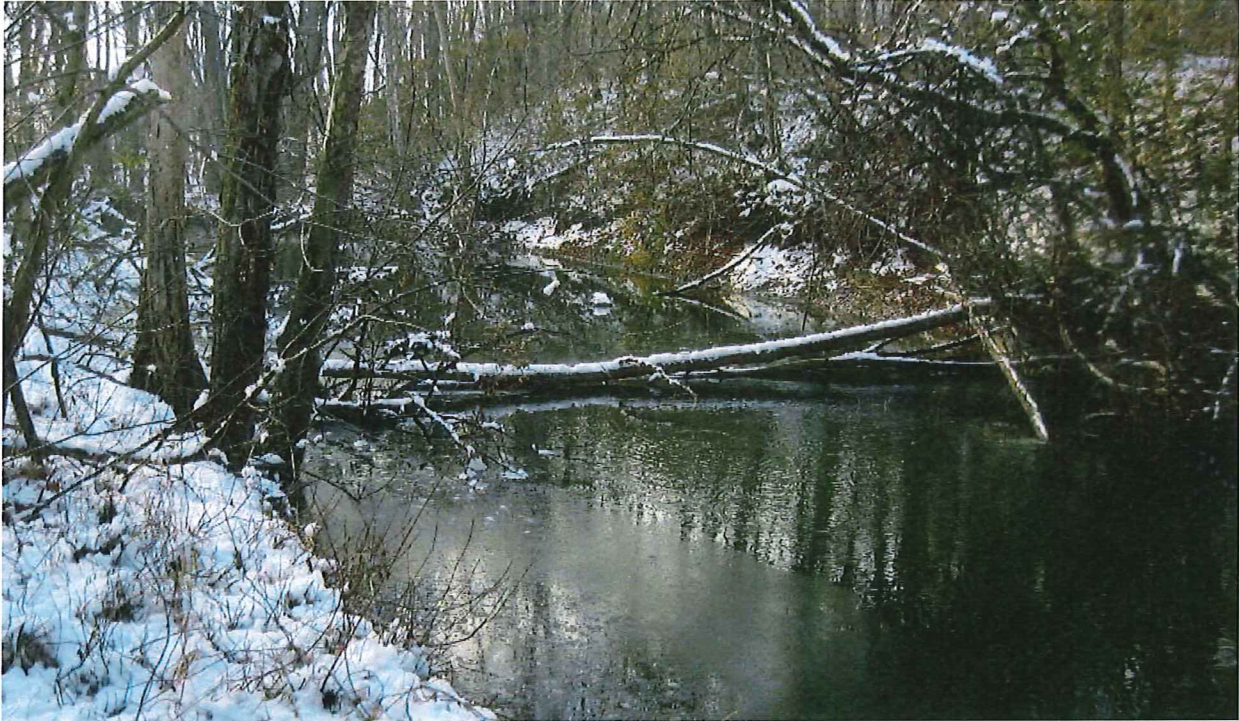
Photo 92 (Section 5 – southeast bank looking upstream): Tree blocking navigation through river past Highway 223 Bridge
