**APPENDIX E –
DEPTH ISSUE INSPECTION PHOTOS**

River Depth Issues

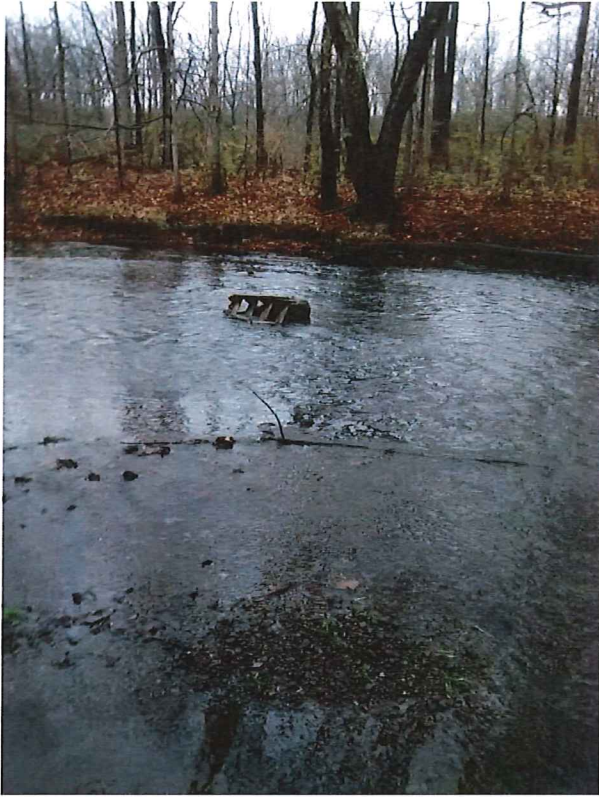
Photo 1 (Section 1 – east bank looking across river): Area near the eastern bank is shallow

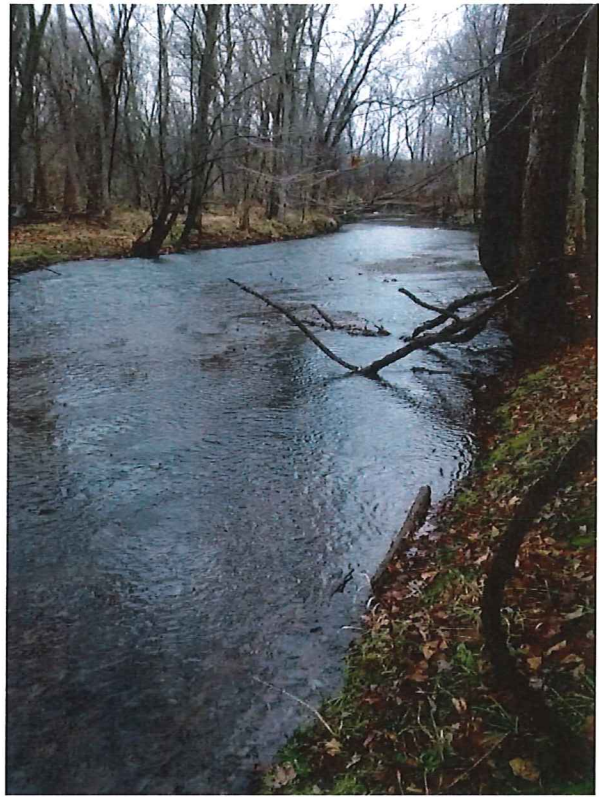
Photo 2 (Section 1 – south bank looking downstream): Area near south bank shallow

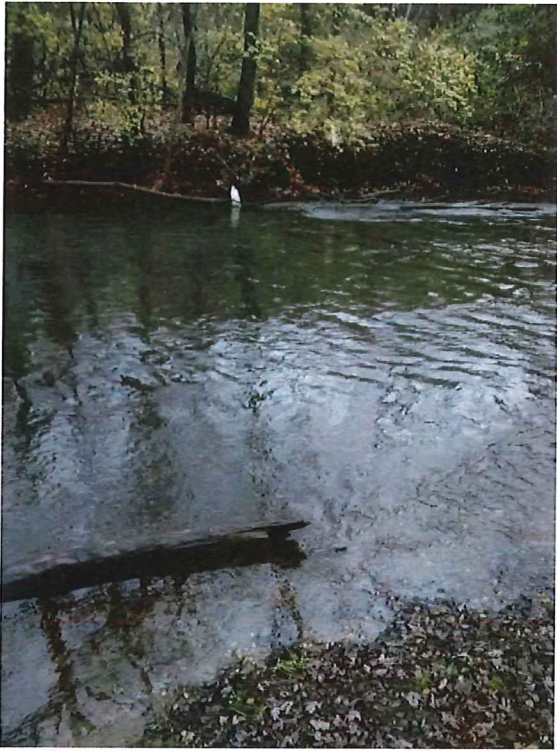
Photo 3 (Section 1 – east bank looking across river): Shallow area in river

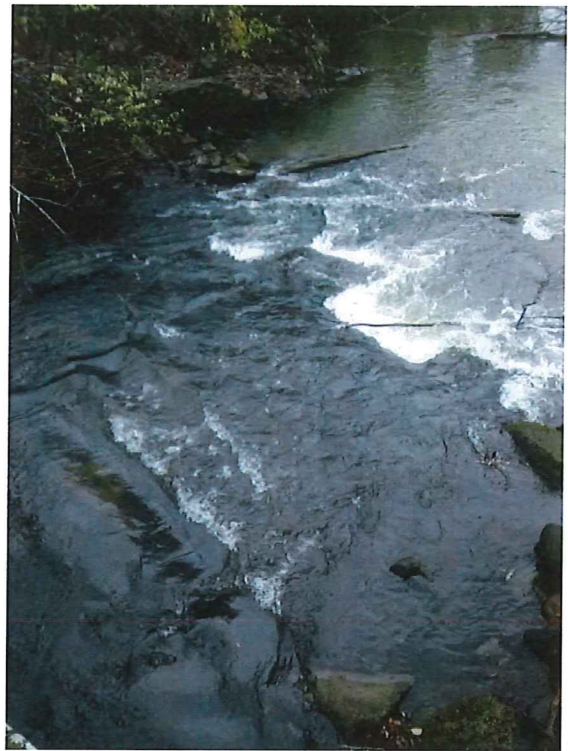
Photo 4 (Section 1 – east bank looking downstream): Rocky, shallow water

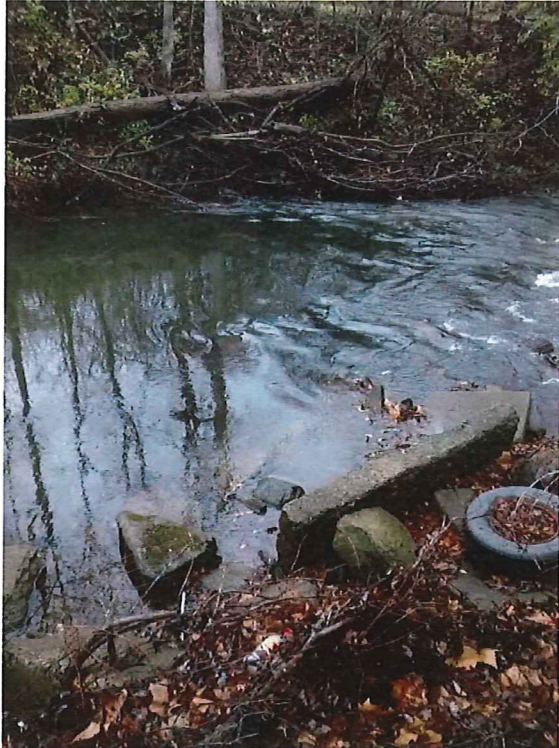
Photo 5 (Section 1 – east bank looking across river): Large rocks and debris on bank creating turbulent flow conditions in river

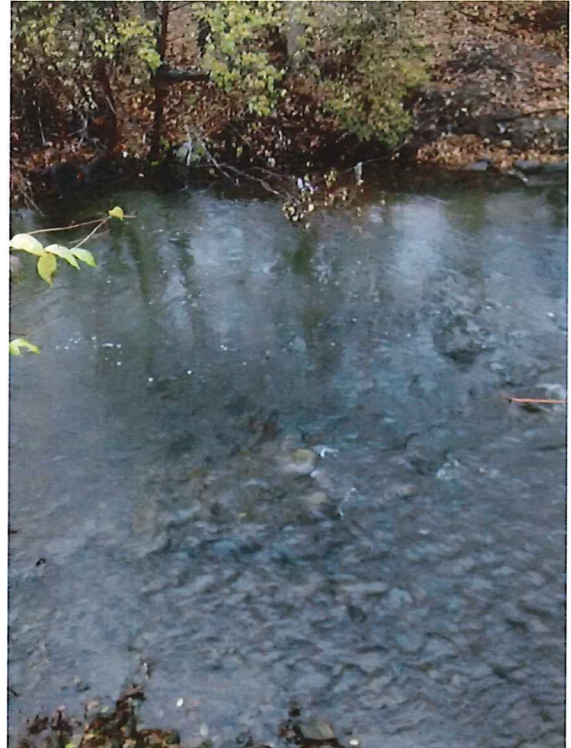
Photo 6 (Section 1 – east bank looking across river): Shallow rocky area near east bank

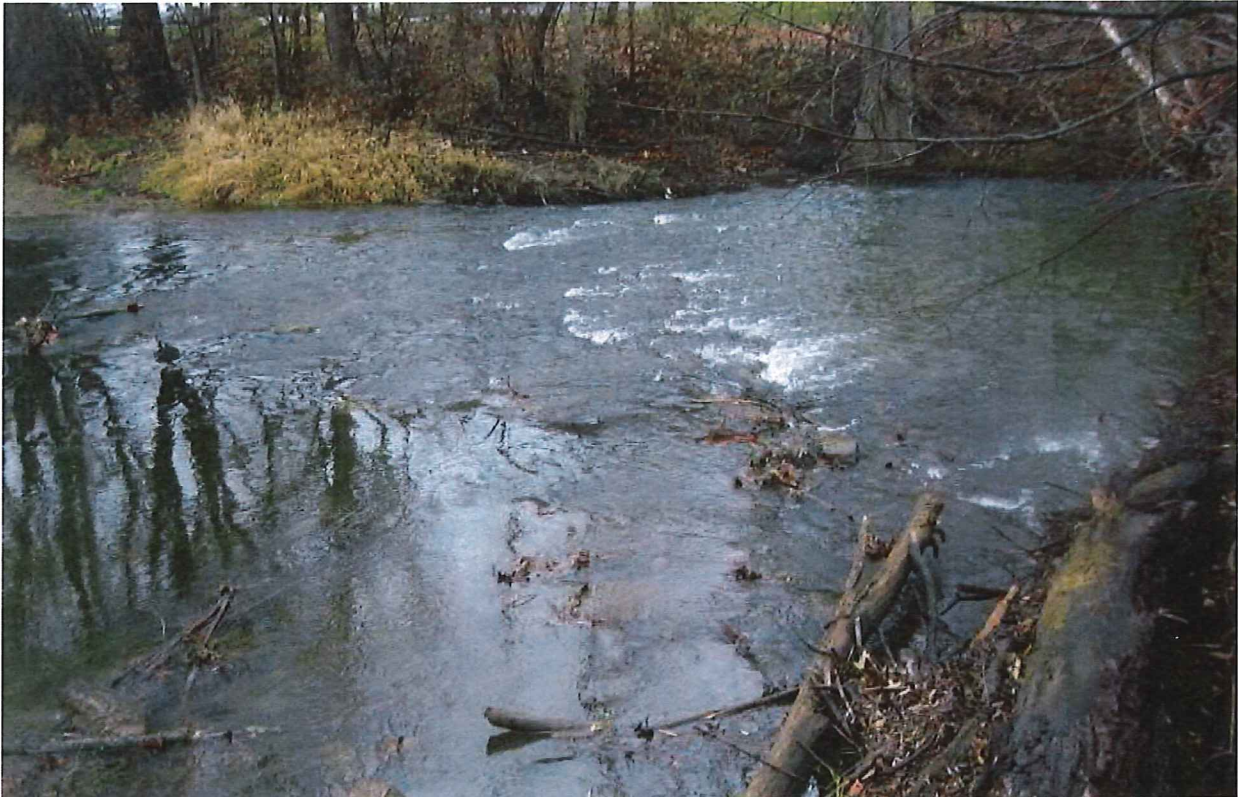
Photo 7 (Section 1 – east bank looking across river at the bend): Shallow and rocky turbulent flow conditions across river

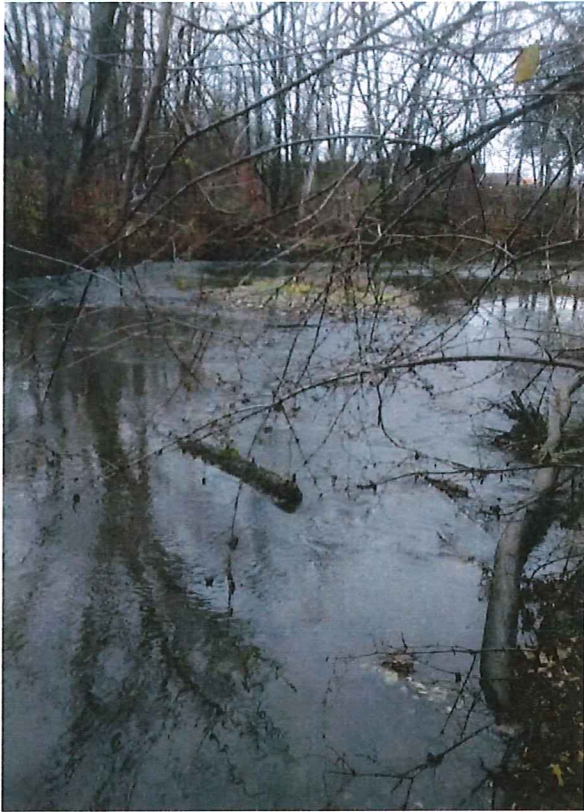
Photo 8 (Section 2 – east bank looking downstream): Shallow area near island in center of river

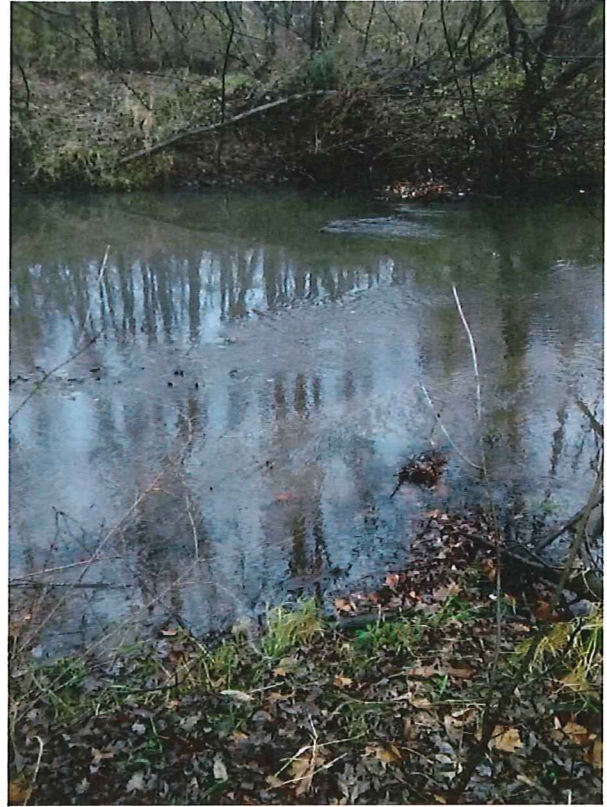
Photo 9 (Section 2 – south bank looking across river): Shallow spot near south bank

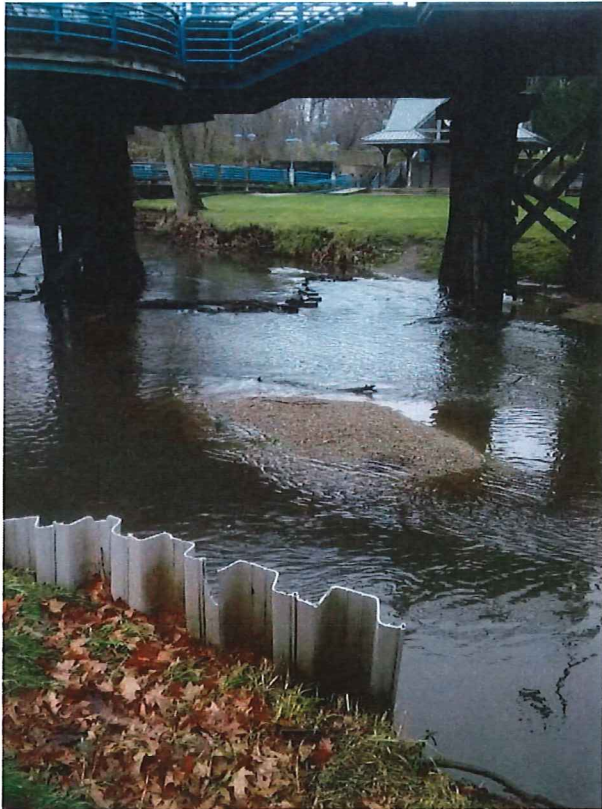
Photo 10 (Section 2 – south bank looking upstream): Shallow spot under bridge

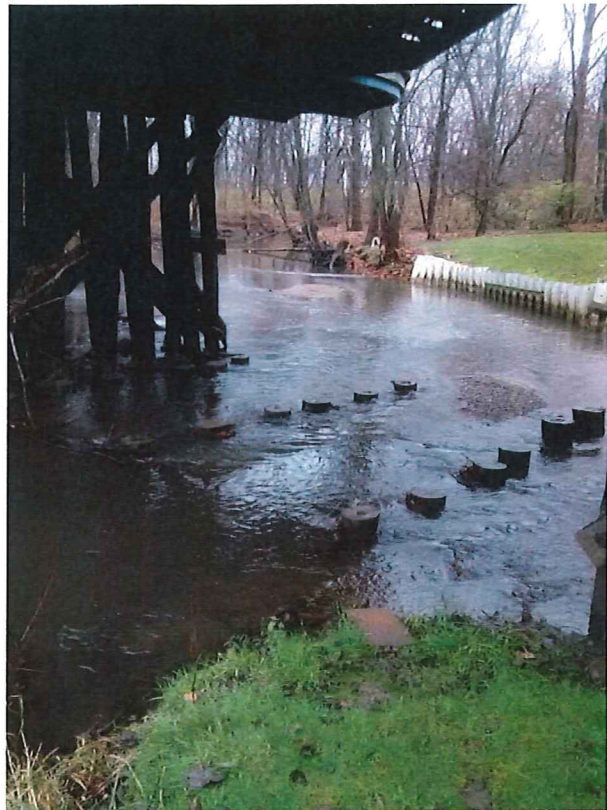
Photo 11 (Section 2 – south bank looking downstream): Shallow area under bridge with posts embedded in ground

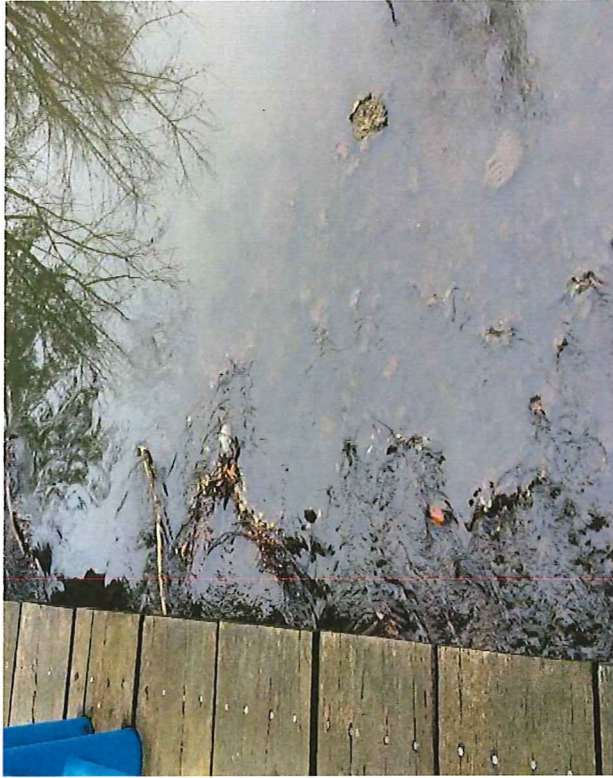
Photo 12 (Section 2 – north bank on Kiwanis Bridge looking down): Rocky, shallow conditions under walking bridge

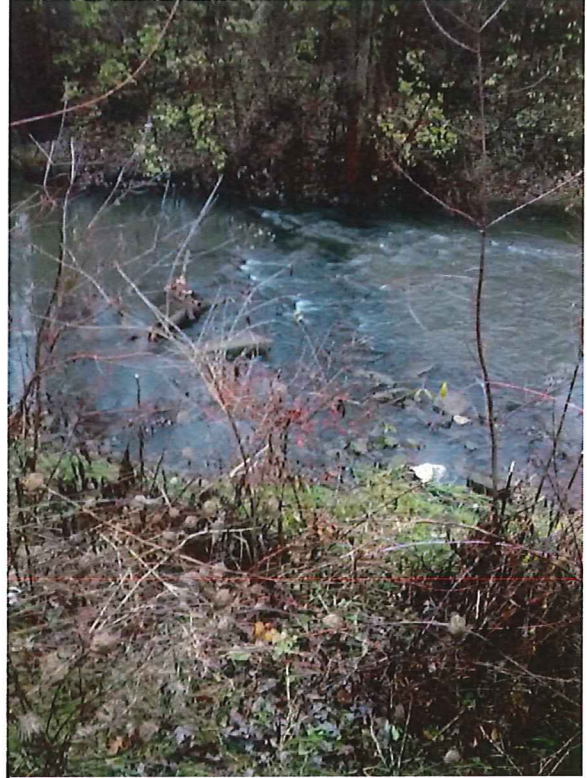
Photo 13 (Section 2 – east bank looking across river): Shallow rocky conditions creating turbulent flow

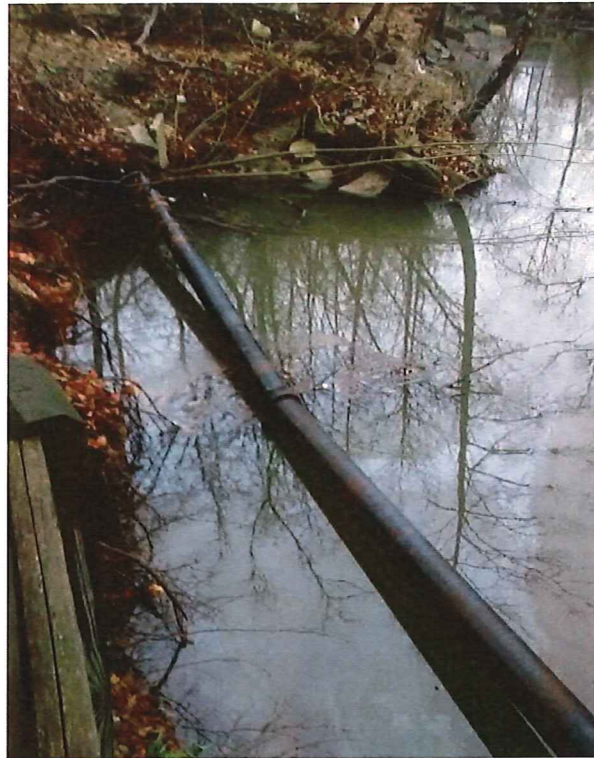
*Photo 14 (Section 2 – west bank on Kiwanis trail):
Pipe crossing shallow area north of main river area*

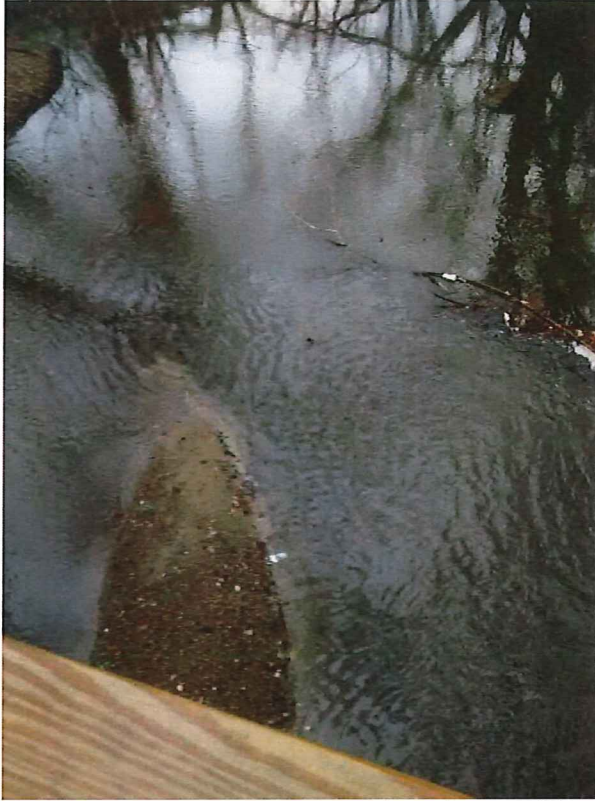
Photo 16 (Section 3 – Looking down from walking bridge): Shallow area under bridge

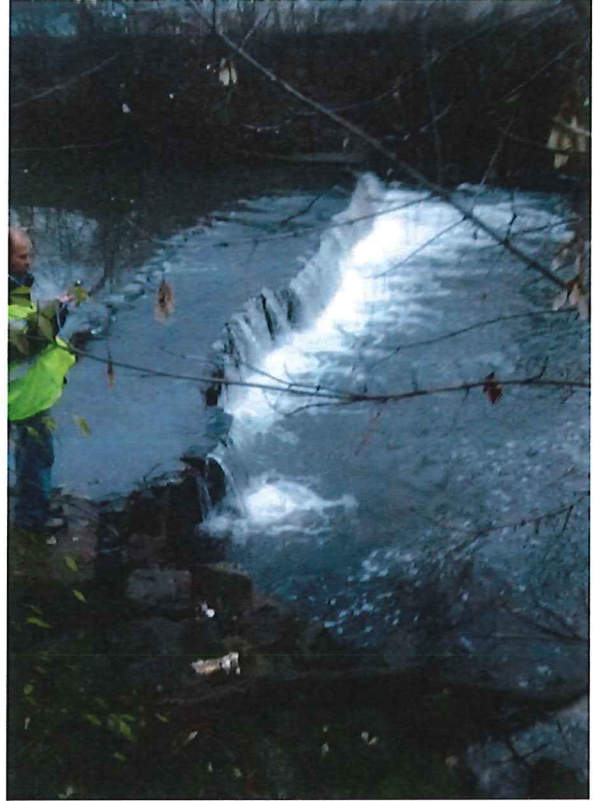
Photo 17 (Section 3 – south bank looking across river): Concrete dam in river creating a 2-foot drop

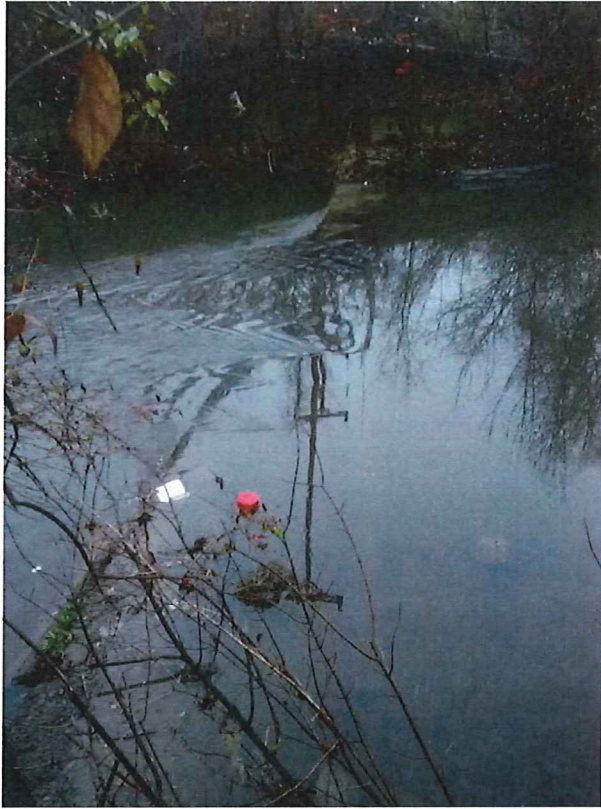
Photo 18 (Section 3 – south bank looking across river): Concrete dam in river mostly submerged

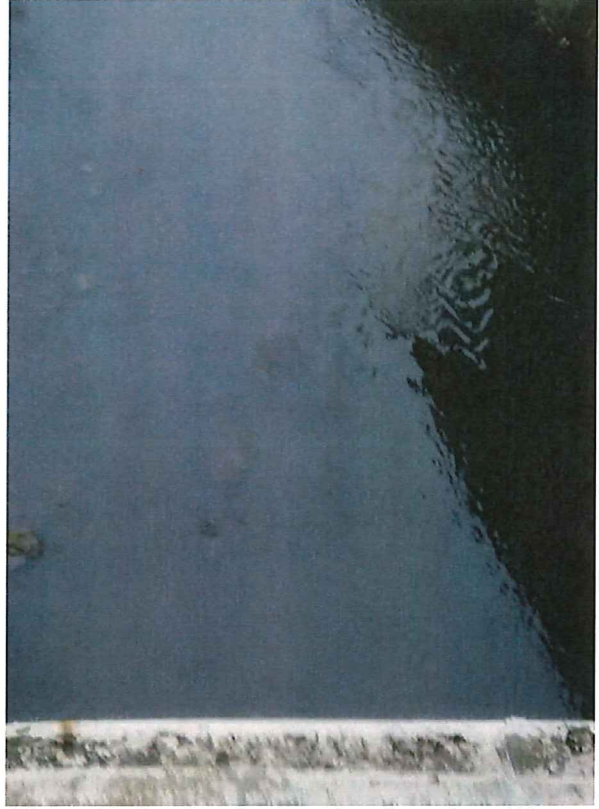
Photo 19 (Section 3 – Looking down from W Maumee Street Bridge): Shallow rocks under bridge

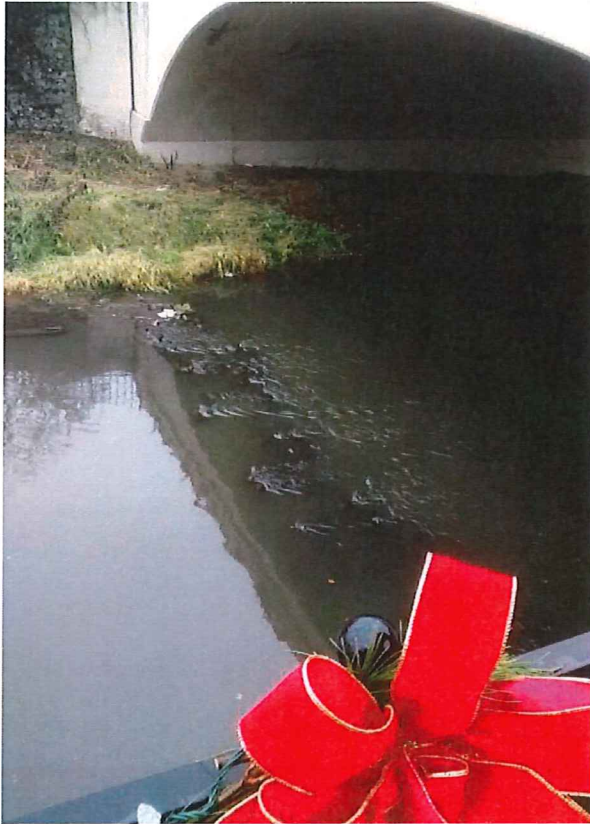
Photo 20 (Section 3 – east bank looking across river under Maumee St. Bridge): Rocks under bridge create shallow conditions in river.

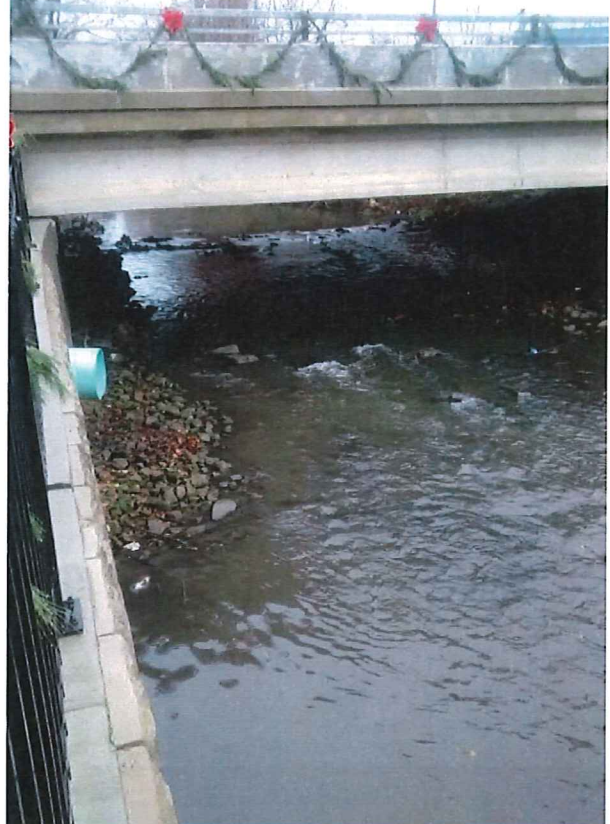
Photo 21 (Section 3 – south bank looking upstream under W Church St. Bridge): Rocks under bridge create rough shallow flow conditions.

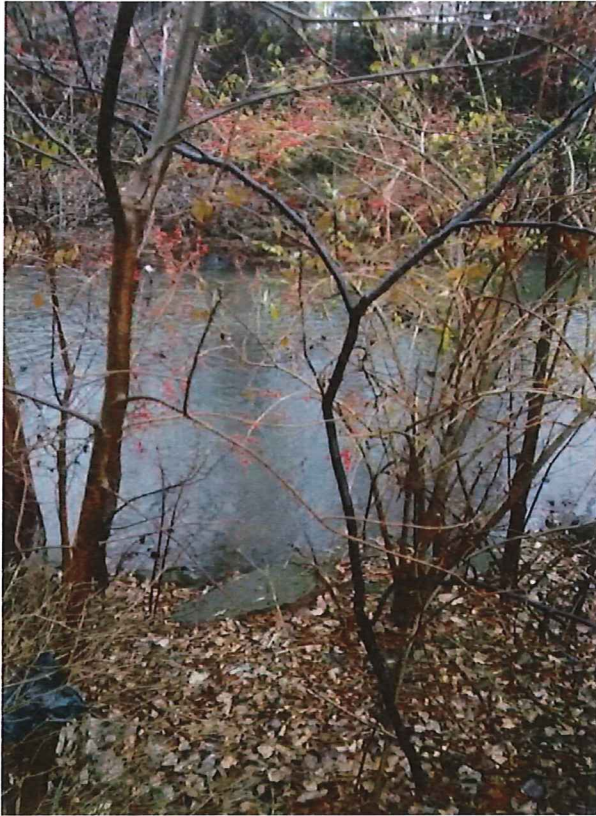
Photo 22 (Section 3 – south bank looking across river): Rocky and shallow area in river

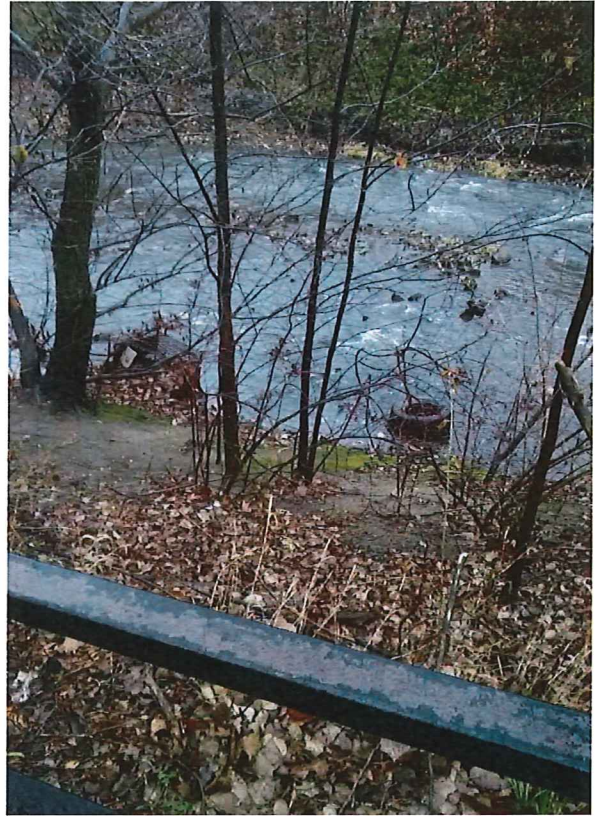
Photo 23 (Section 3 – south bank looking across river): Rocky and shallow area near south bank and turbulent conditions on north bank

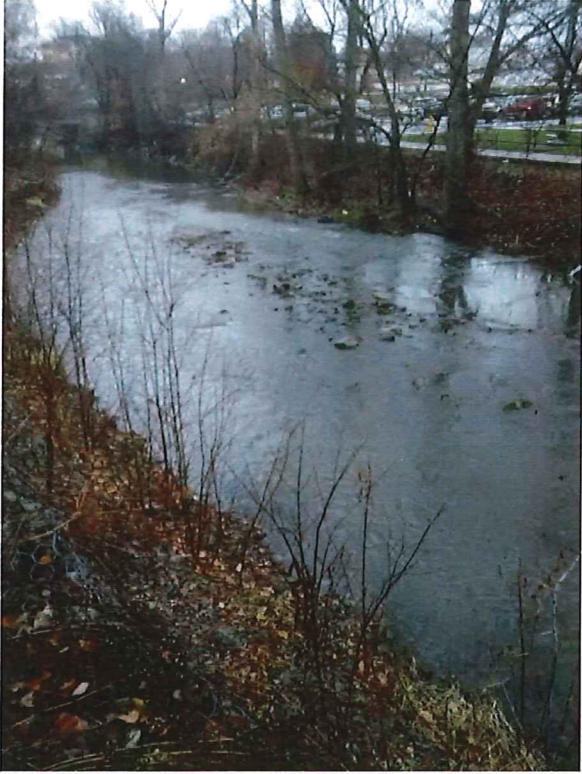
Photo 24 (Section 3 – north bank looking downstream): Rocky and shallow center of river

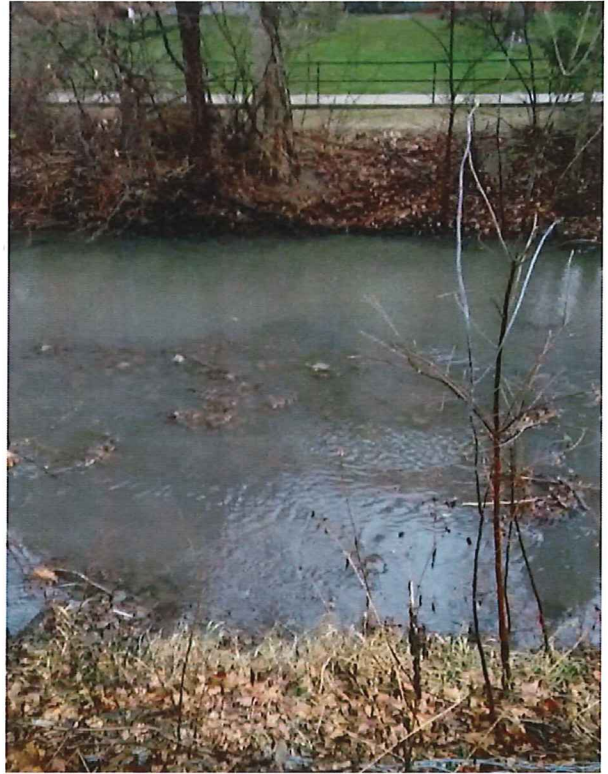
Photo 25 (Section 3 – north bank looking across river): Rocky and shallow center of river

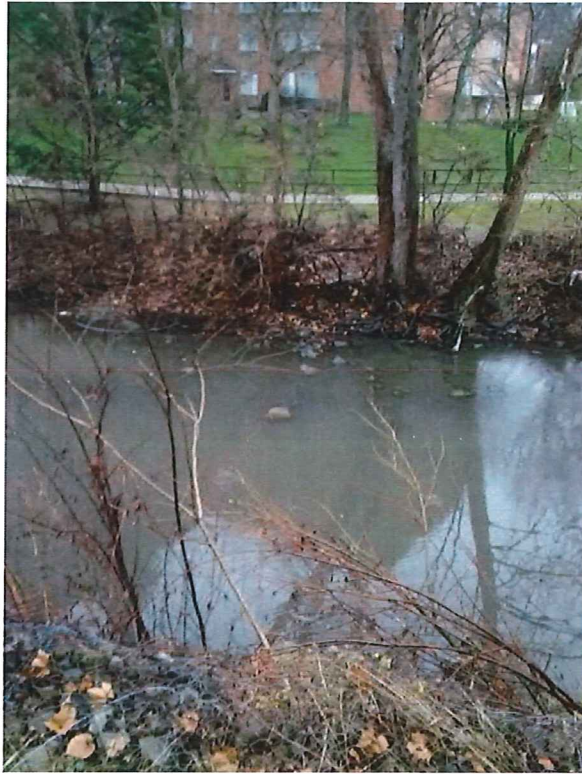
Photo 26 (Section 3 – north bank looking across river): Rocky and shallow near south bank of river

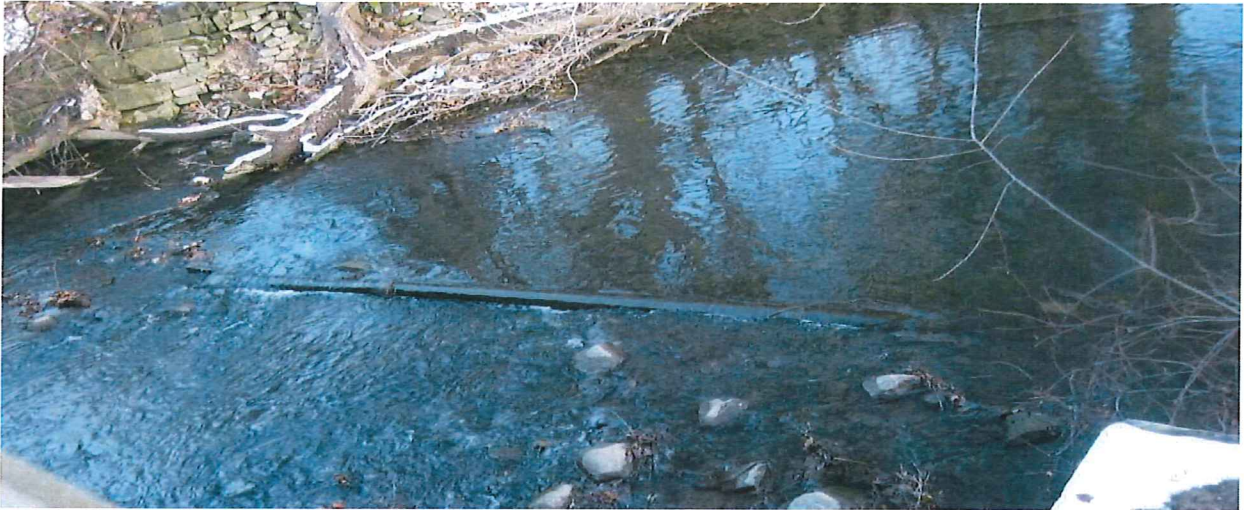
Photo 27 (Section 4 – Looking down from College Avenue Bridge south side): Pipe breaks surface of water

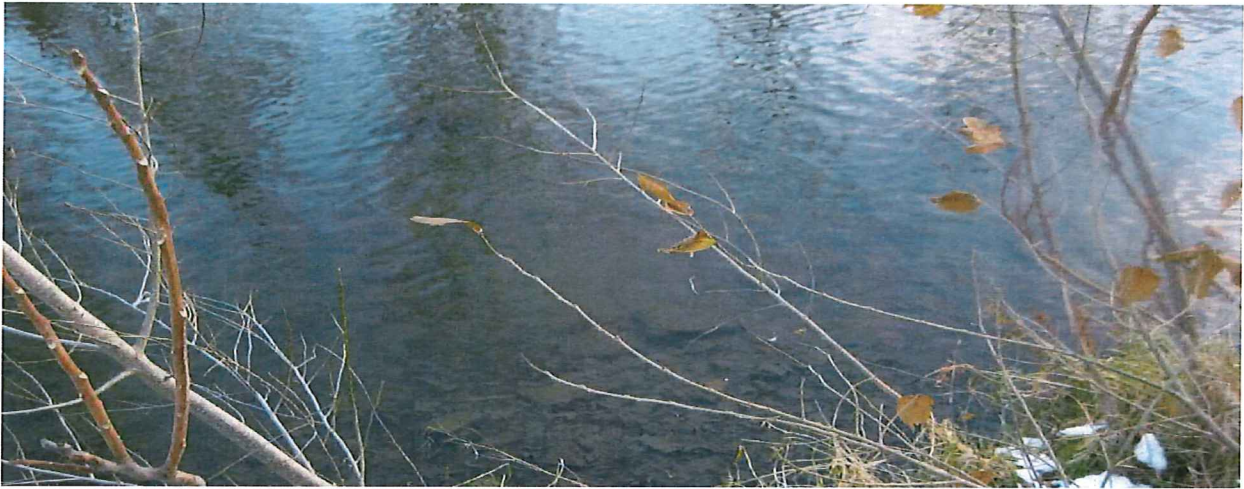
Photo 28 (Section 4 – west bank looking across river): Large shallow rocks in river area

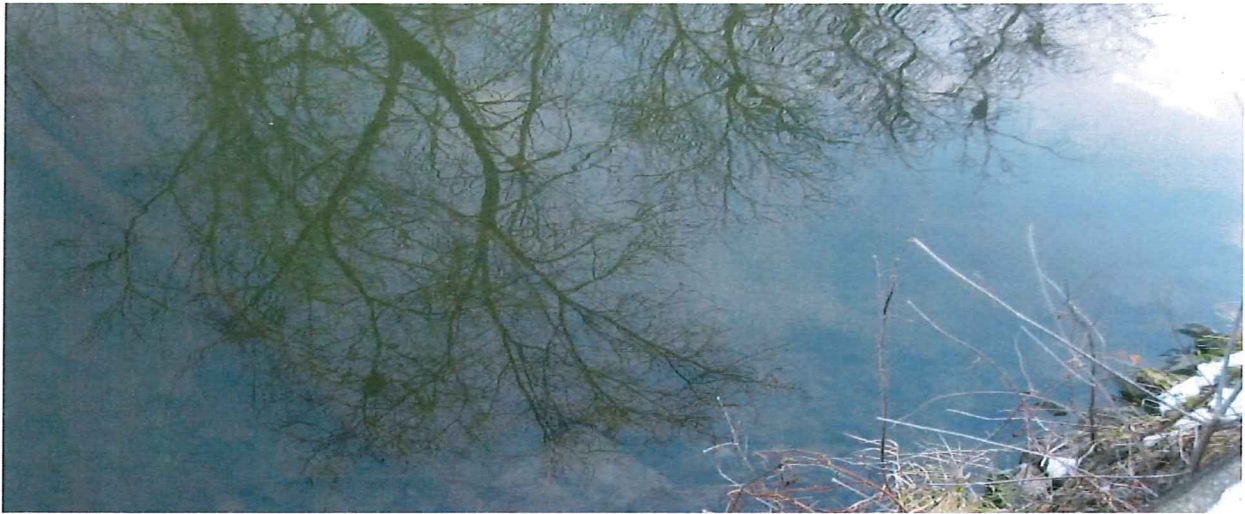
Photo 29 (Section 4 – west bank looking into river): Pipe and metal debris crossing through river

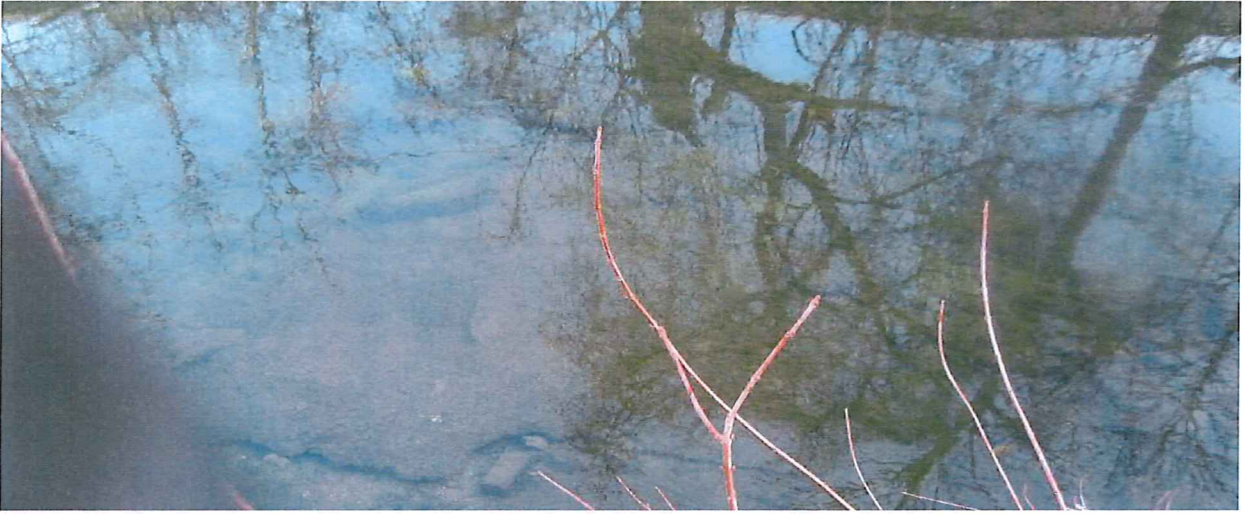
Photo 30 (Section 4 – west bank looking into river): Shallow area with metal debris

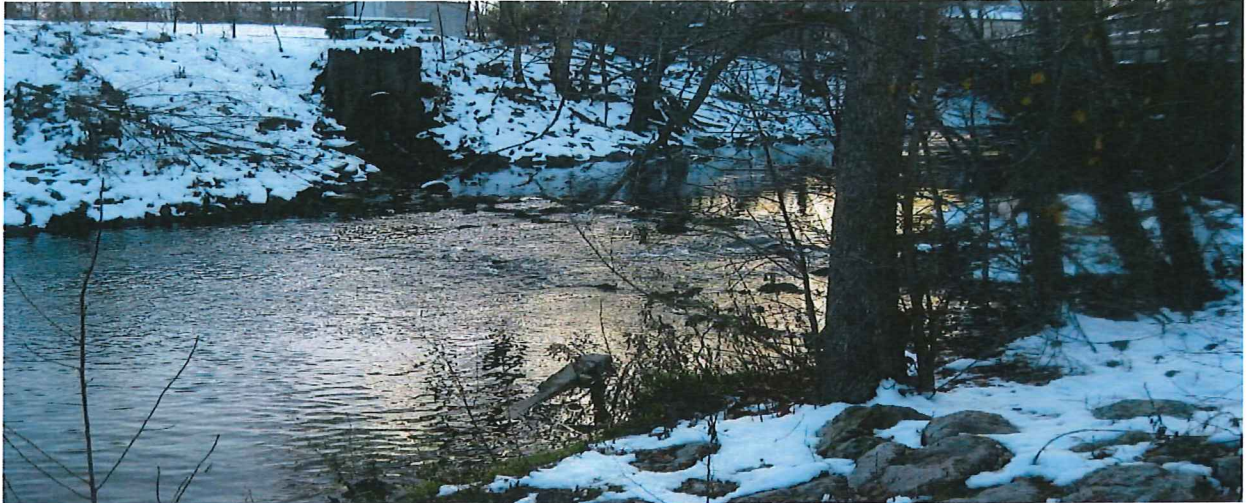
Photo 31 (Section 4 – north bank looking upstream): Rocky shallow zone near outfall

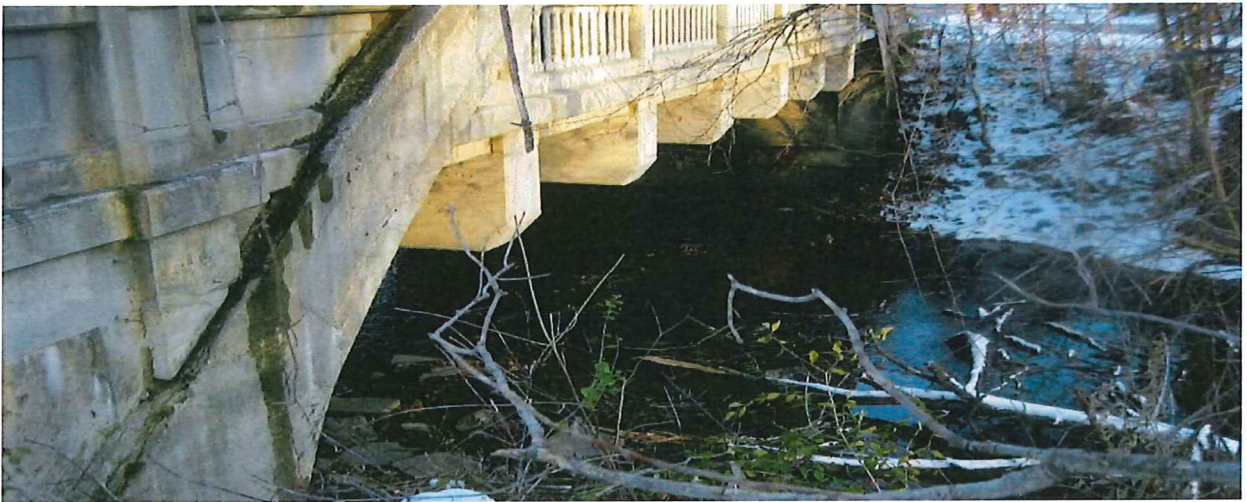
Photo 32 (Section 4 – north bank looking downstream under Merrick Street Bridge): Shallow and rocky under bridge

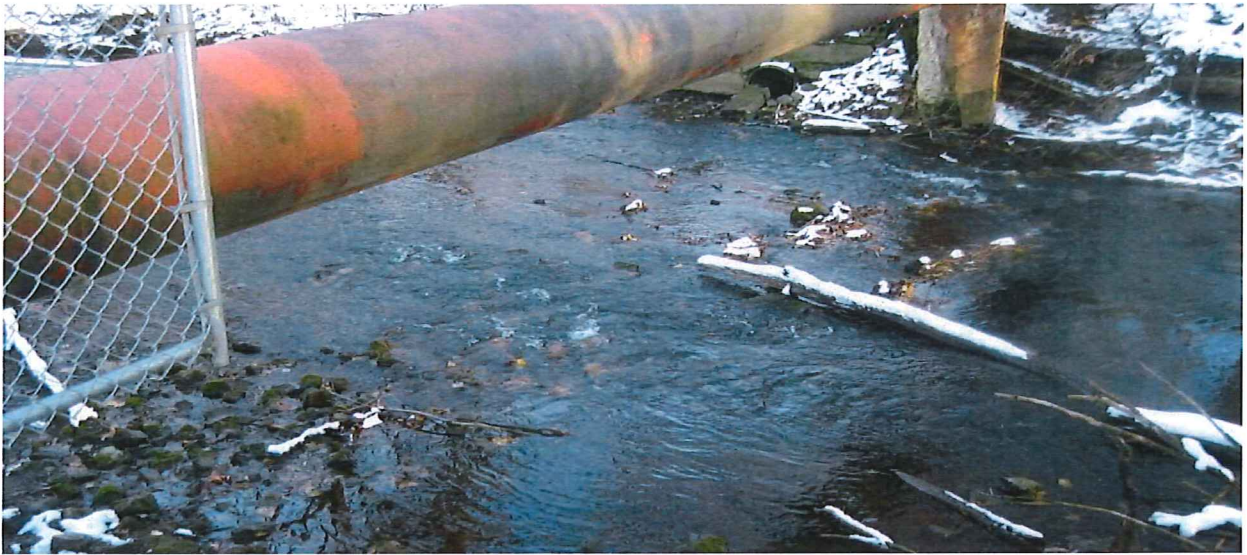
Photo 34 (Section 4 – north bank looking upstream): Shallow rocks under overhanging pipe

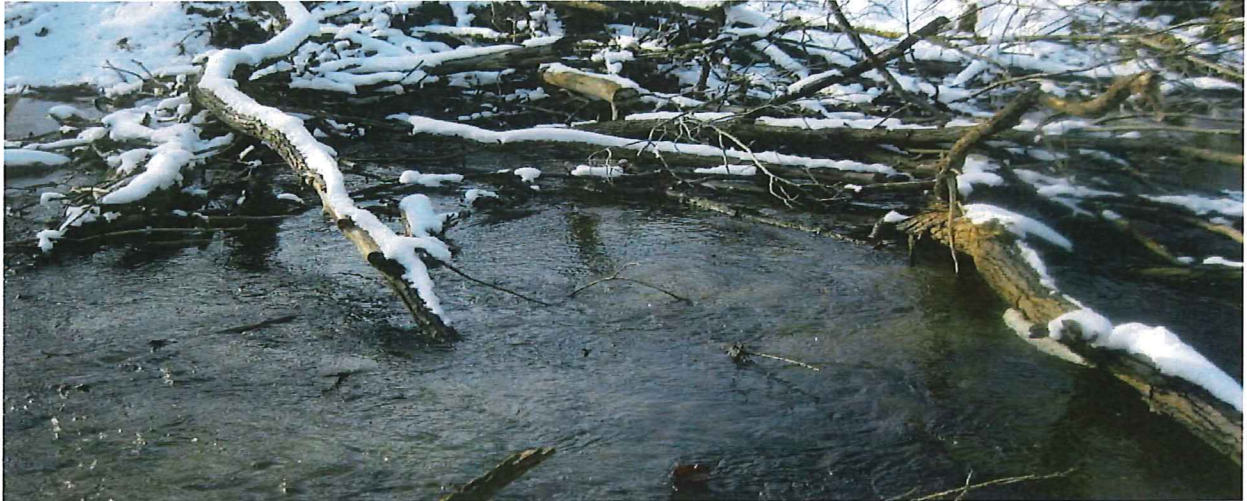
Photo 40 (Section 5 – east bank looking across river at the bend): Shallow area near bend

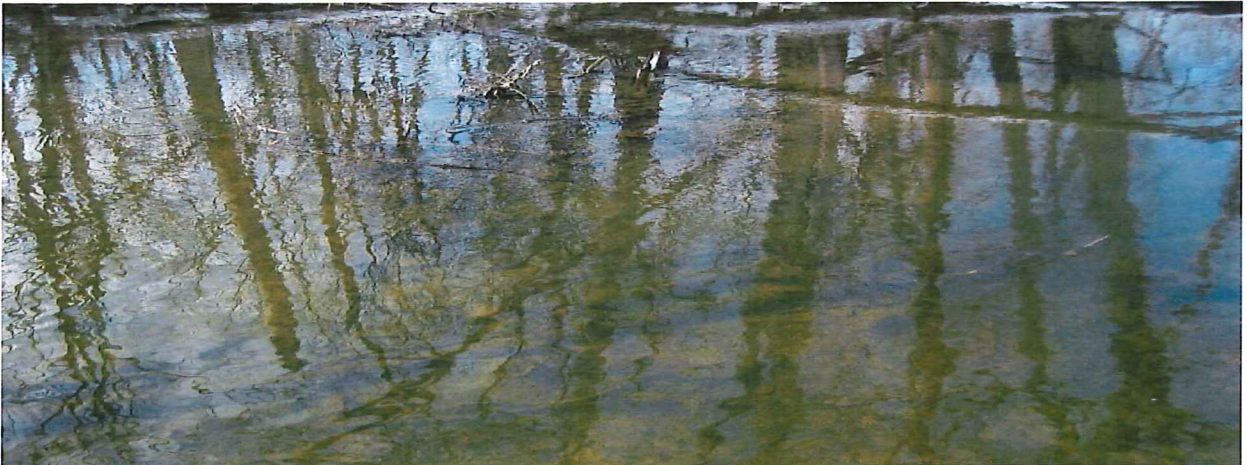
Photo 41 (Section 5 – east bank looking across river): Smooth and shallow across this river section

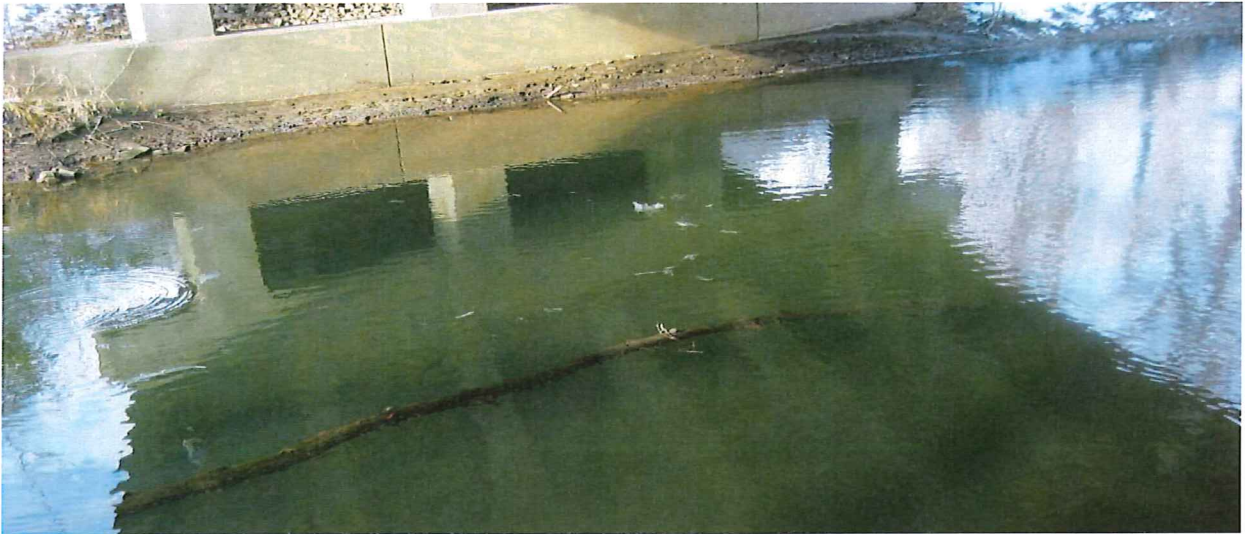
Photo 42 (Section 5 – south bank looking across river under Hwy 223): Shallow flow under bridge area
