APPENDIX D –

RIVER OBSTRUCTION INSPECTION PHOTOS

River Obstructions

Section 1: Howell Highway to Island Park

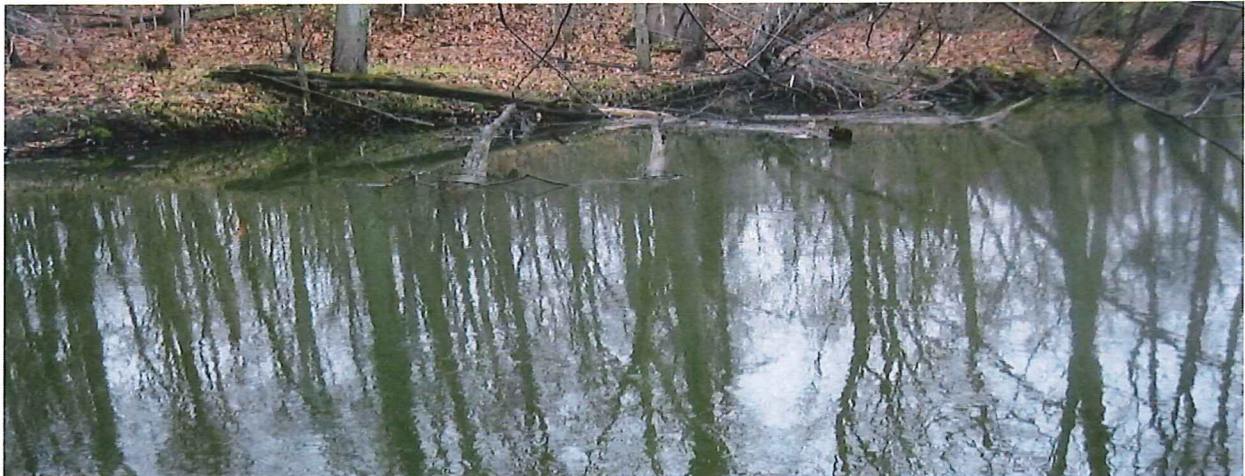
Photo 1 (Section 1 - south bank looking north): Two partly submerged 5" diameter logs cross from one side of the river to the other

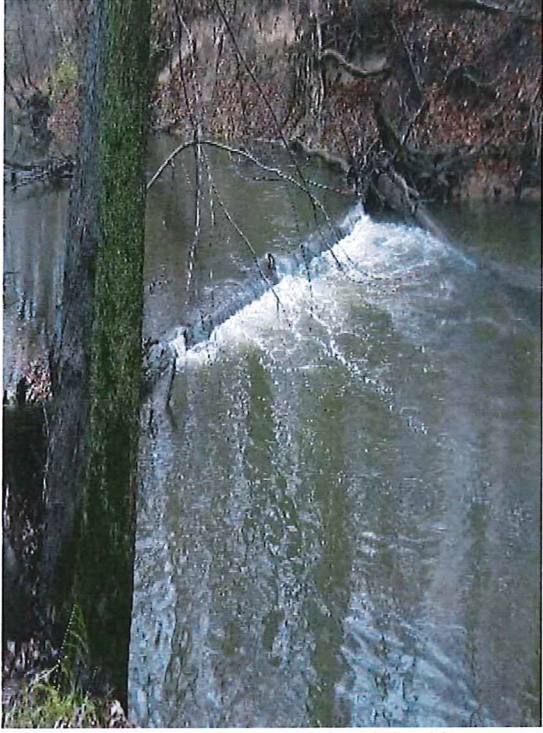
Photo 4 (Section 1 – south bank looking upstream): 8" down tree blocking river flow

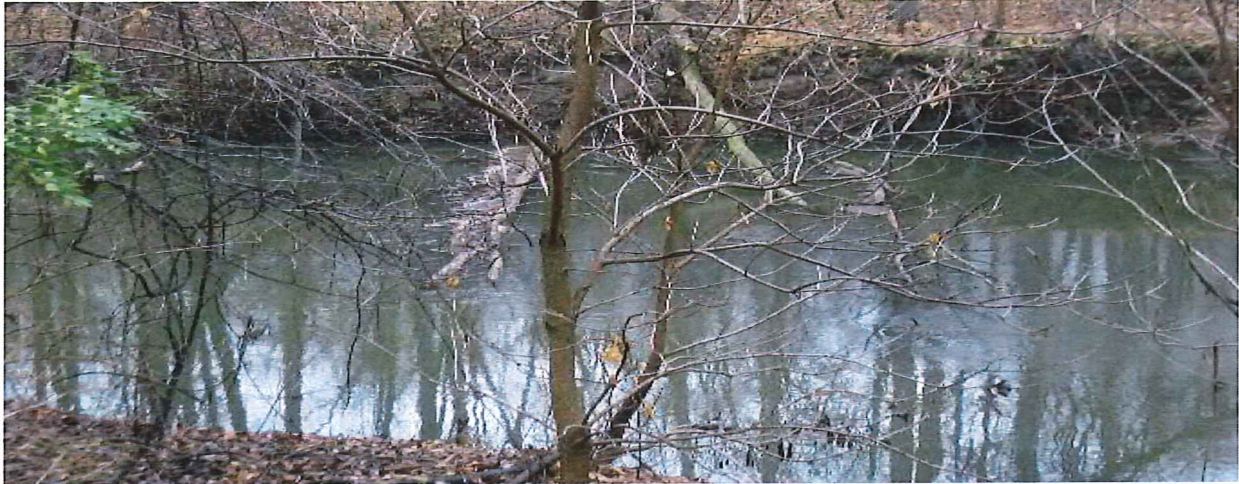
Photo 11 (Section 1 – south bank looking across river): Two 4" trees floating across half the breadth of the river

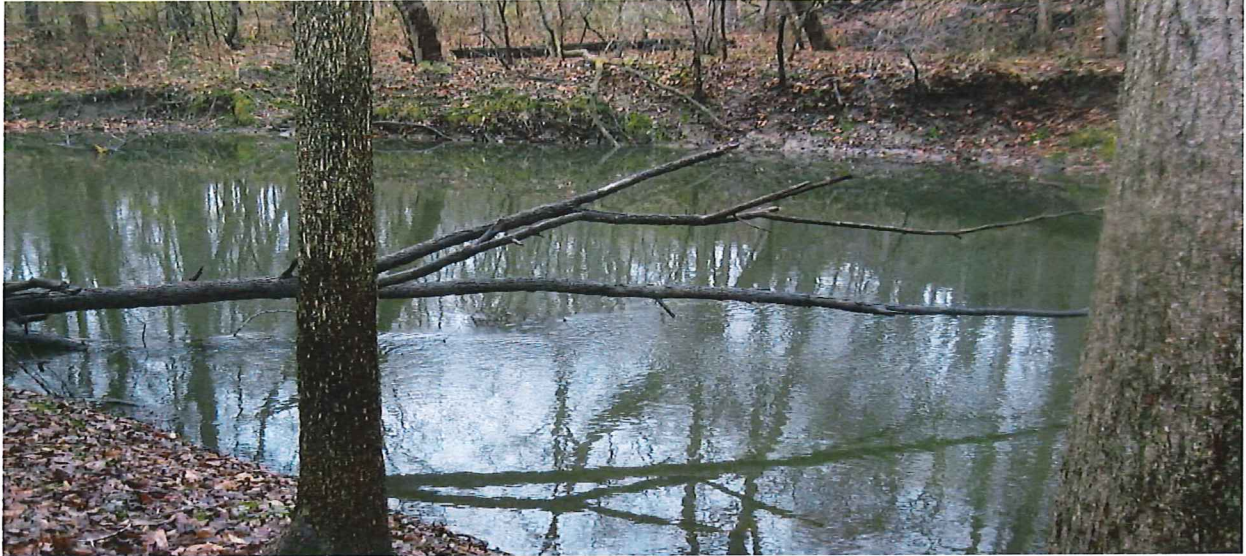
Photo 13 (Section 1 – south bank looking upstream): Overhanging tree partially obstructing path for kayak

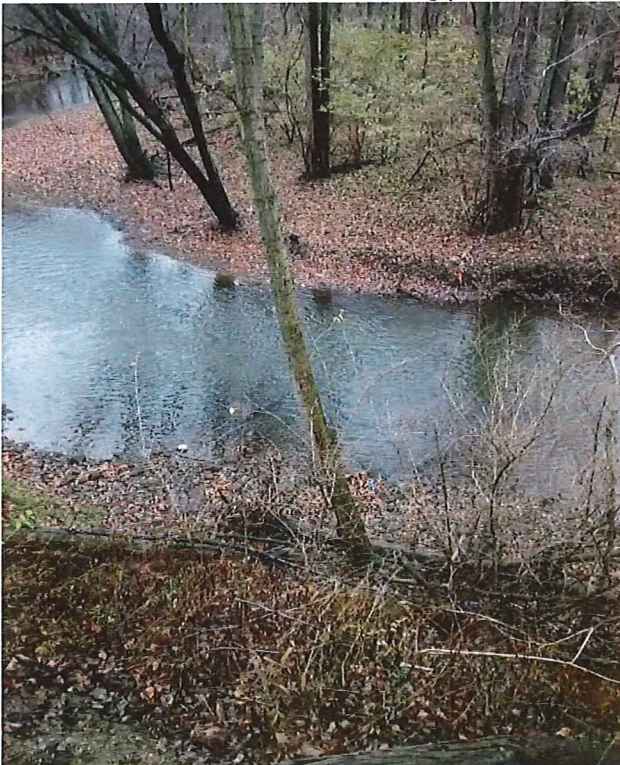
Photo 16 (Section 1 - east bank looking upstream):
Large rocks under water impeding path of kayak

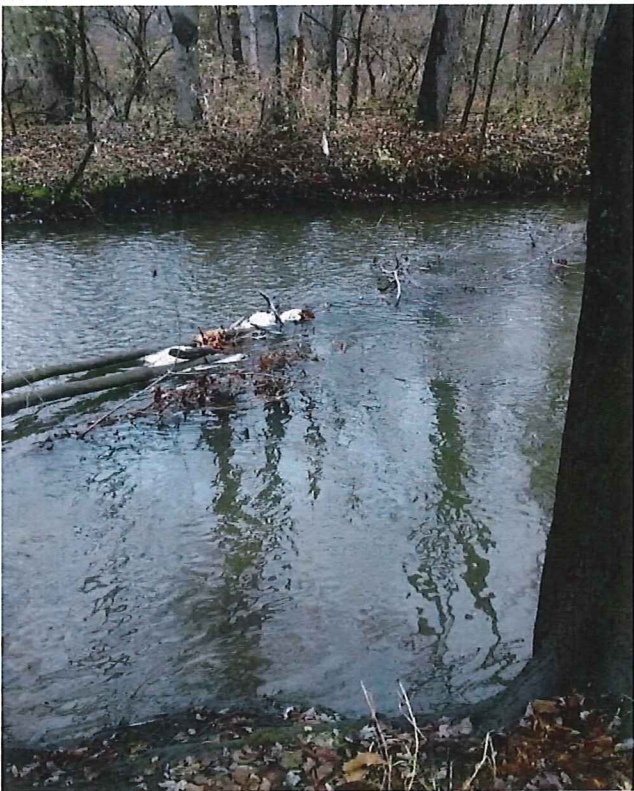
Photo 18 (Section 1 - east bank looking across river):
Two 3"-diameter trees blocking passage over half the width of river

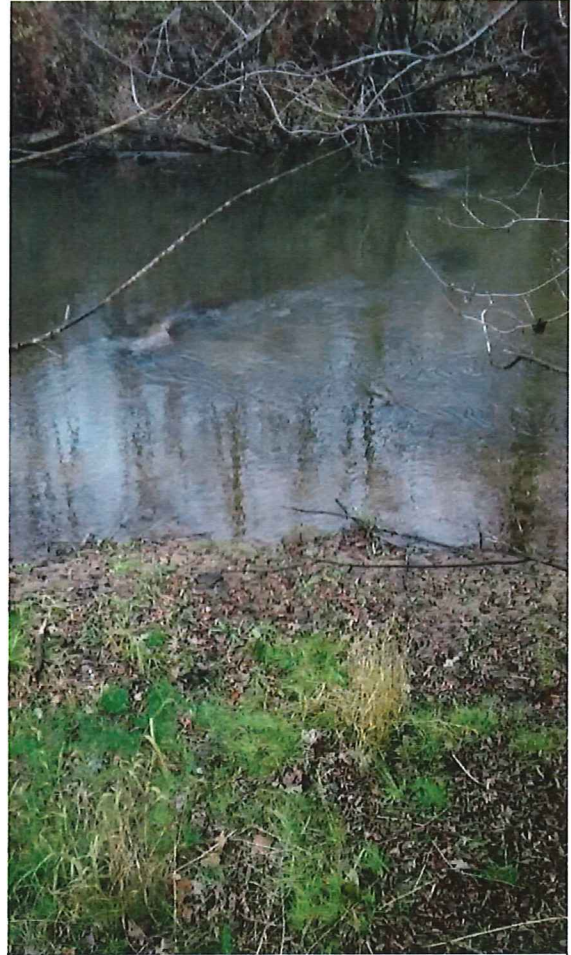
Photo 20 (Section 1 – south bank looking downstream):
Several large rocks in river

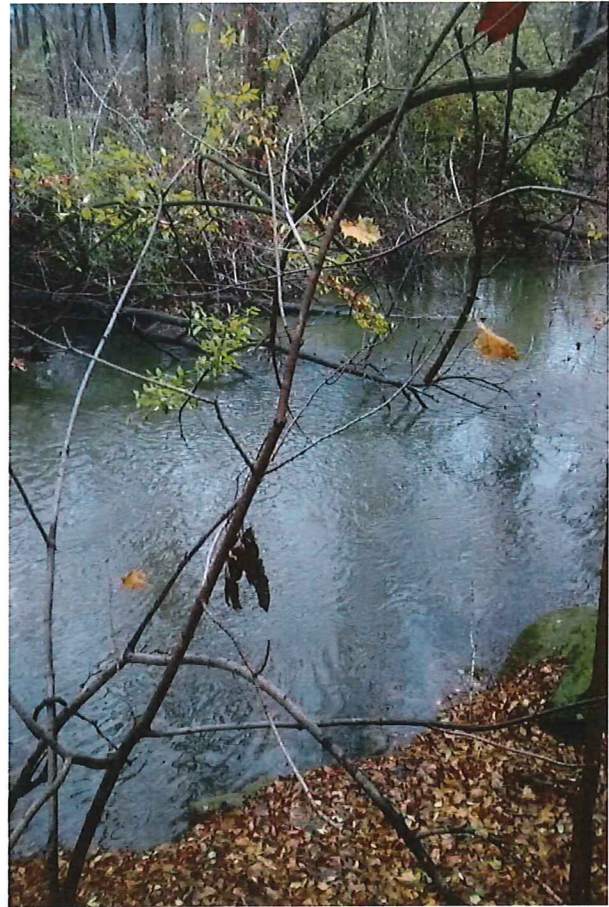
Photo 28 (Section 1 - bank near Island Park looking downstream): Overhanging tree crossing river inhibiting passage by kayak

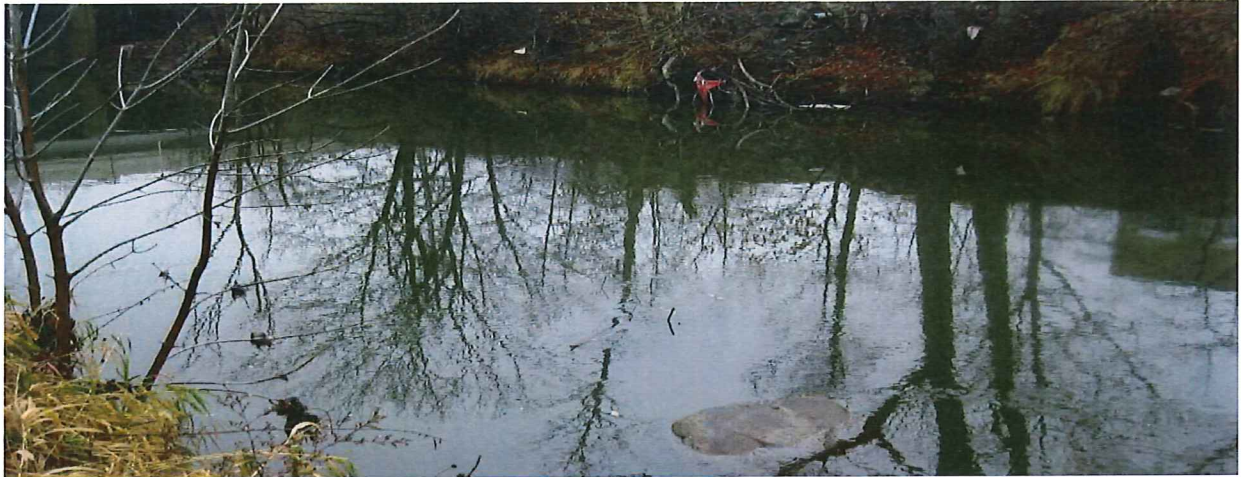
Photo 30 (Section 2 – south bank looking upstream): Three boulders and a tree creating obstacle for river navigation

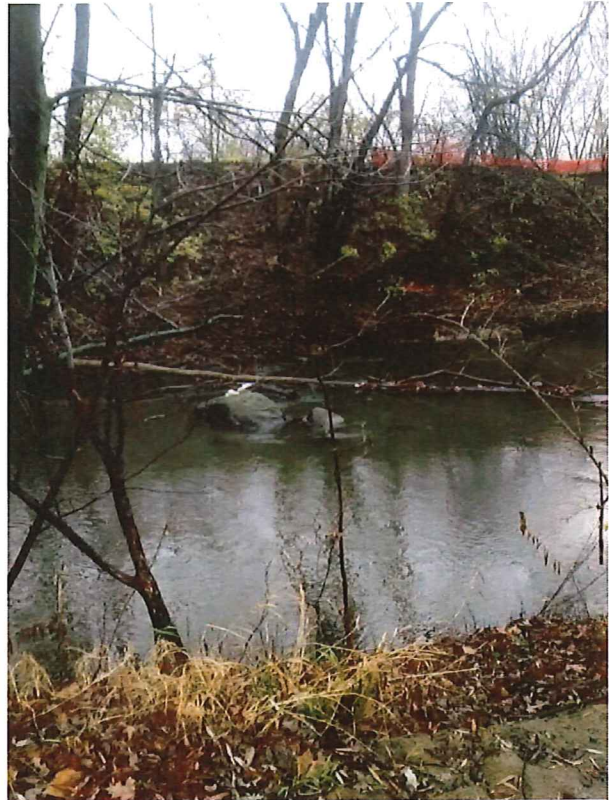
Photo 35 (Section 2 – south bank looking downstream): Downed tree and rocks in river creating a navigation obstacle

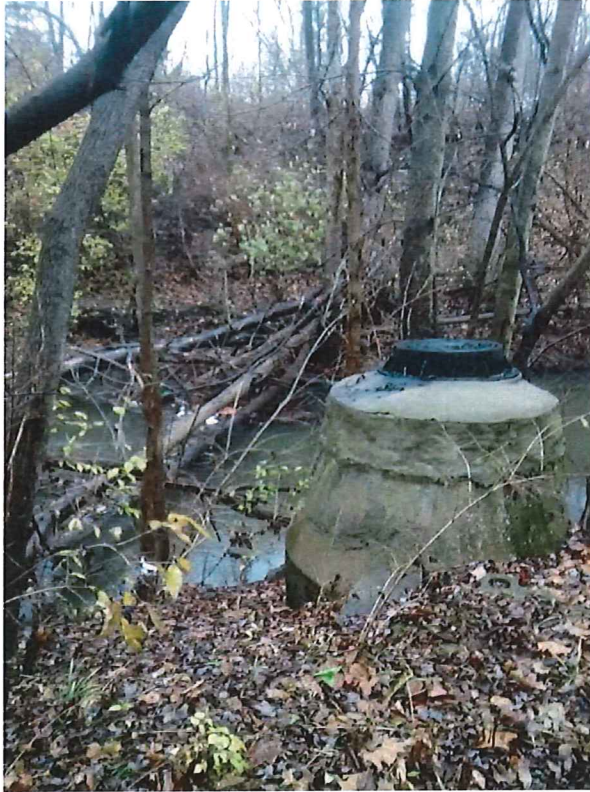
Photo 36 (Section 2 – east bank looking across river): Trees creating barrier for river navigation

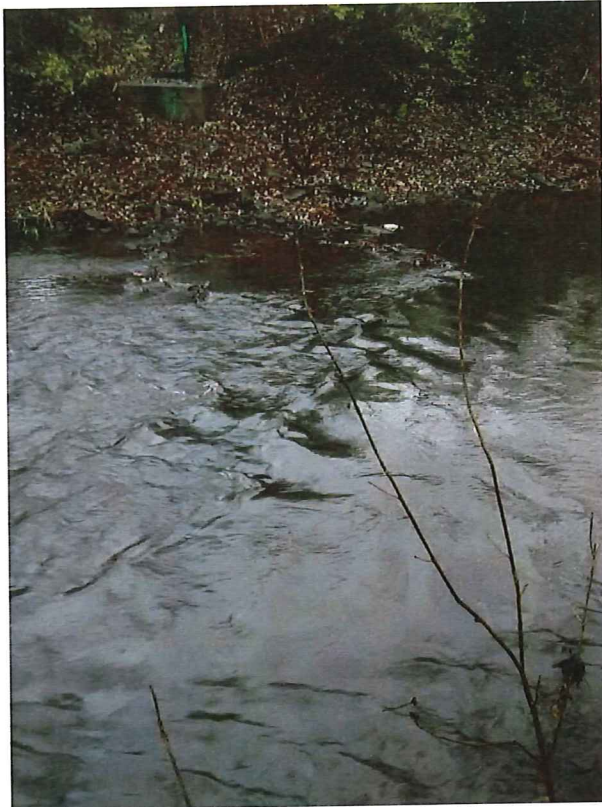
Photo 44 (Section 3 – south bank looking across river): Brush in river inhibiting passage by kayak

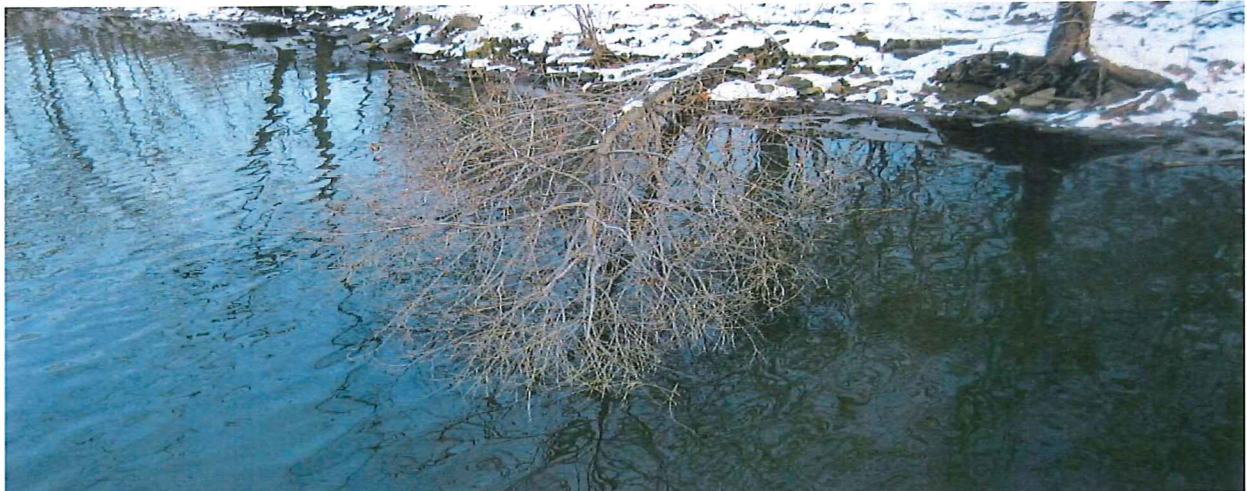
Photo 52 (Section 4 – west bank looking across river): Tree overhanging river on the east bank

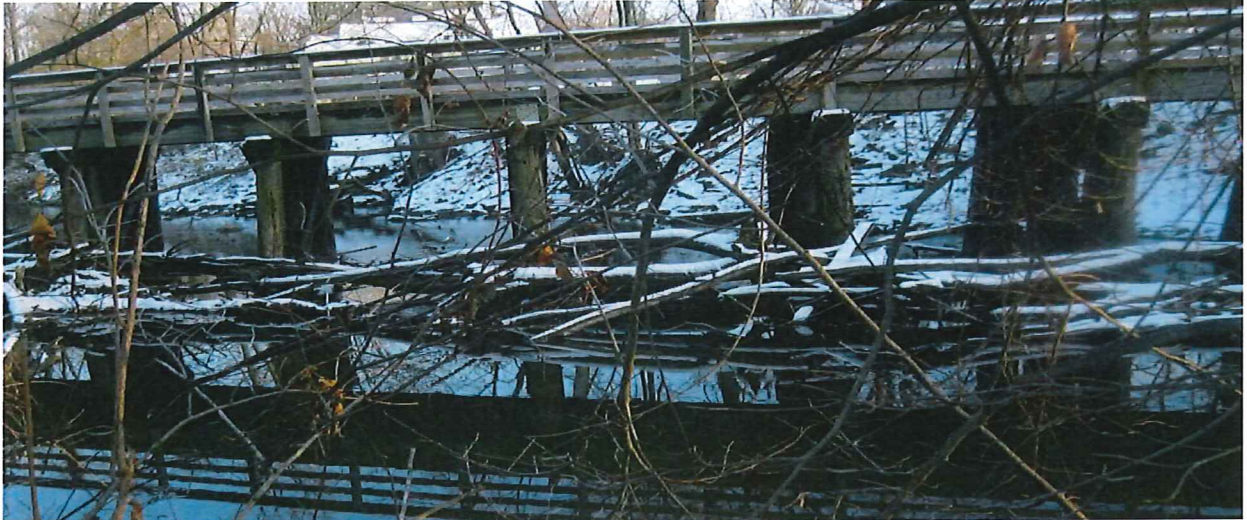
Photo 54 (Section 4 – north bank looking downstream): Piles of branches blocking passage by Kiwanis bridge)

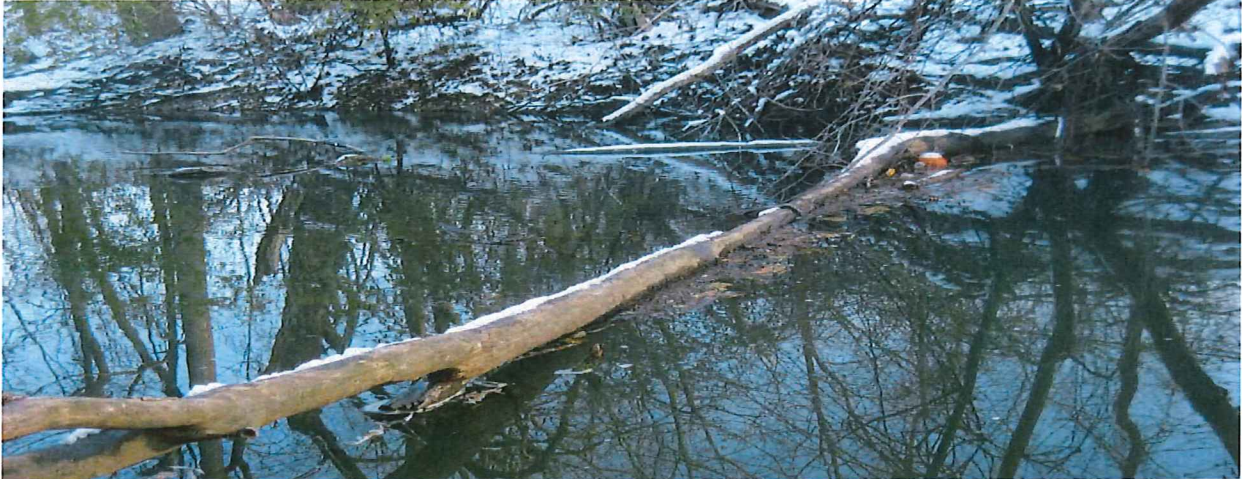
Photo 56 (Section 4 – north bank looking downstream): Downed tree blocking passage through river

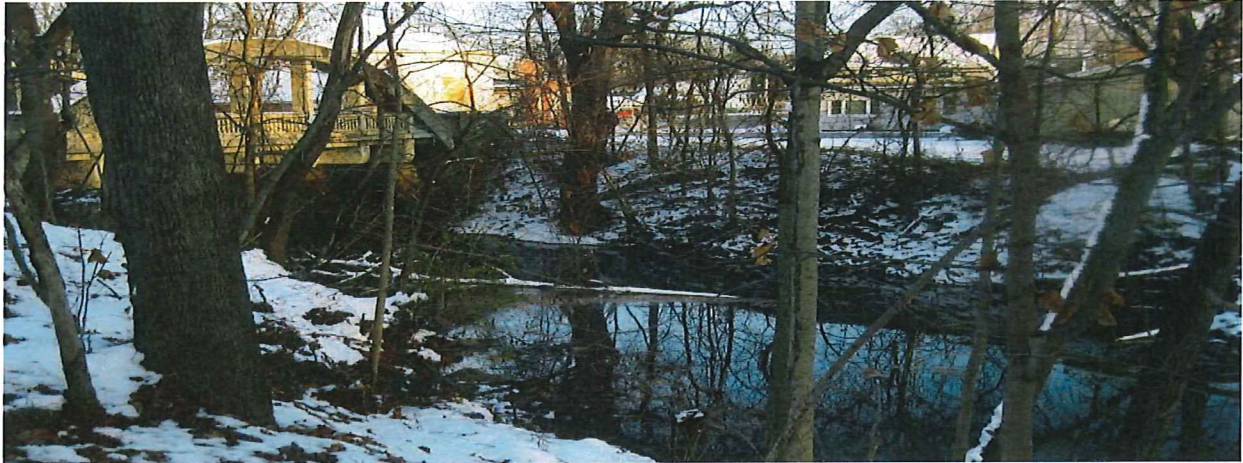
Photo 58 (Section 4 – north bank looking downstream): Downed tree blocking over half the passage through river near Merrick Street Bridge

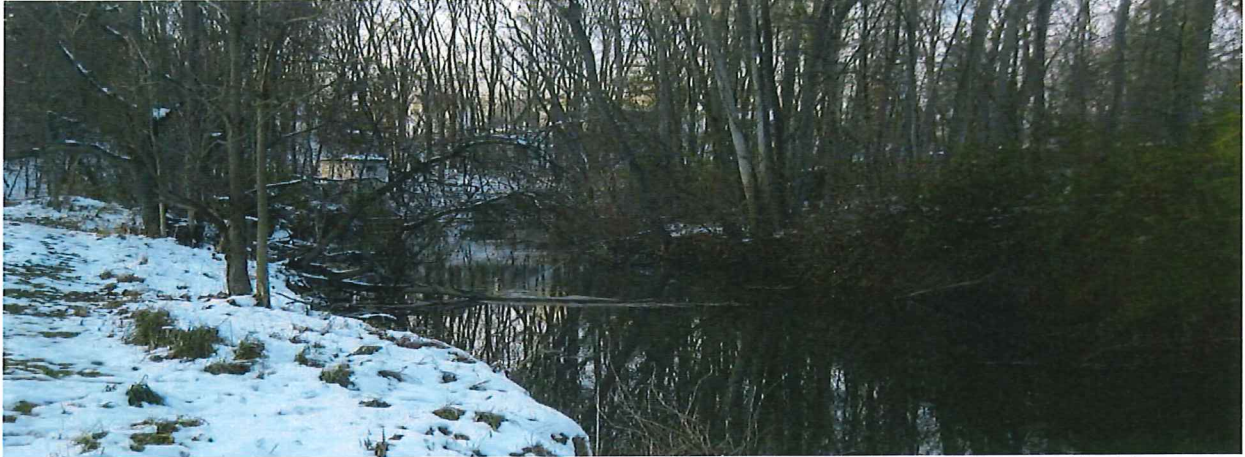
Photo 60 (Section 4 – west bank looking downstream): Tree floating over surface of water blocking passage through river

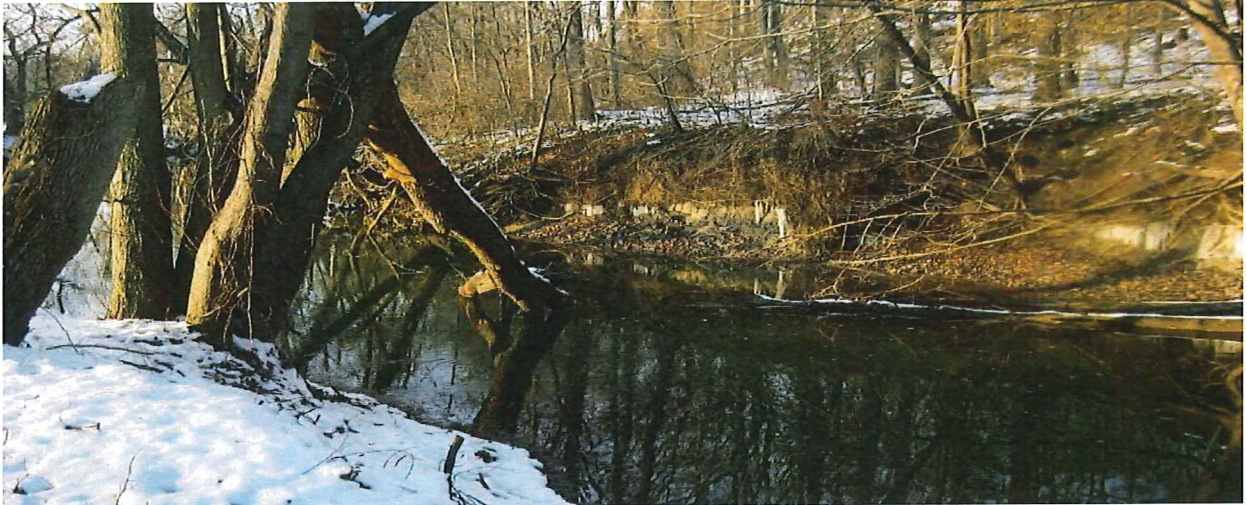
Photo 62 (Section 4 – west bank looking downstream): Downed tree (over 1-foot diameter) jEtting into river and a smaller tree floating nearby

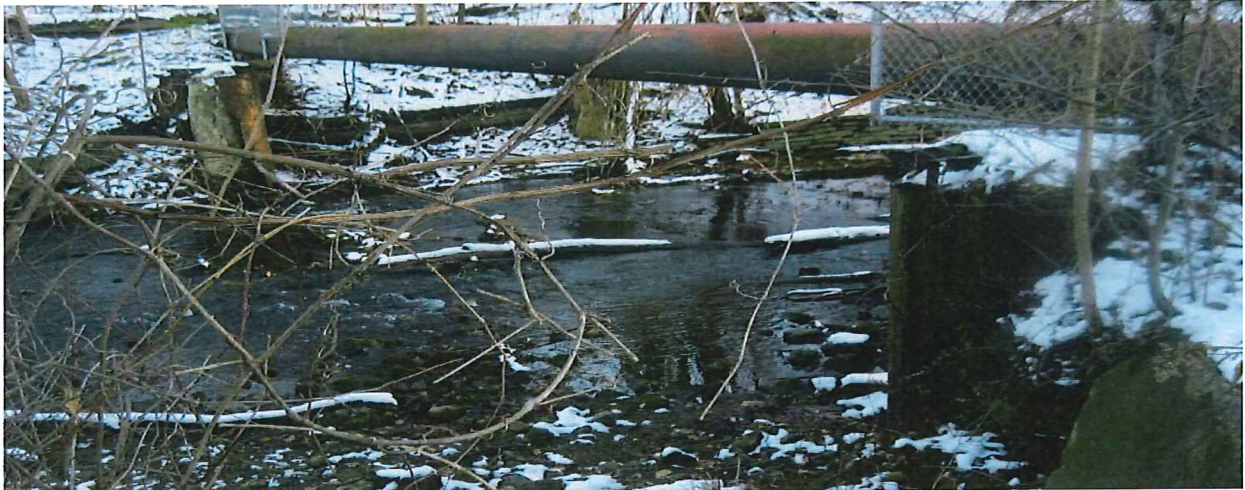
Photo 64 (Section 4 – west bank looking upstream): Tree in middle of river under overhanging pipe

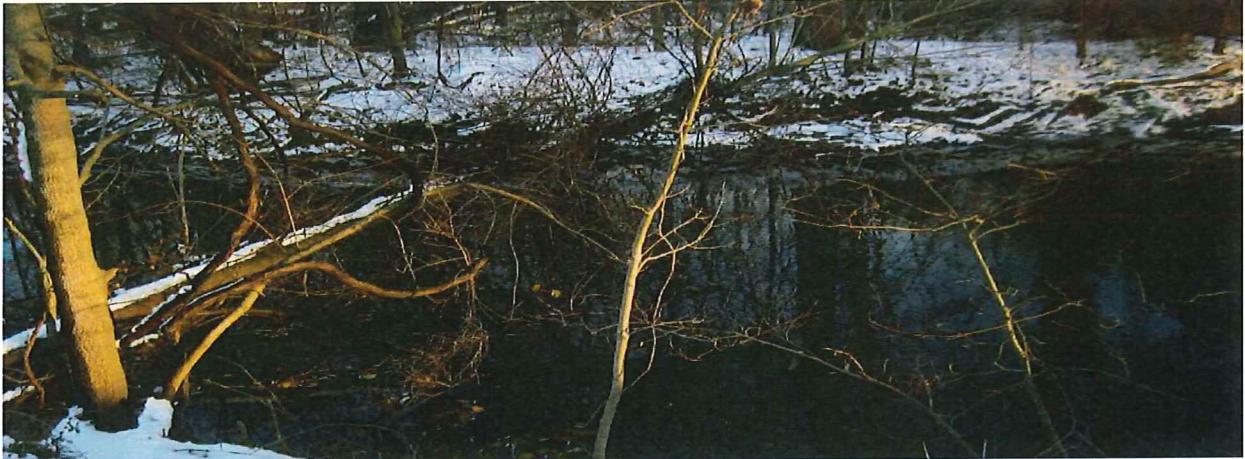
Photo 66 (Section 4 – west bank looking across river): Tree hanging over river obstructing navigation through river

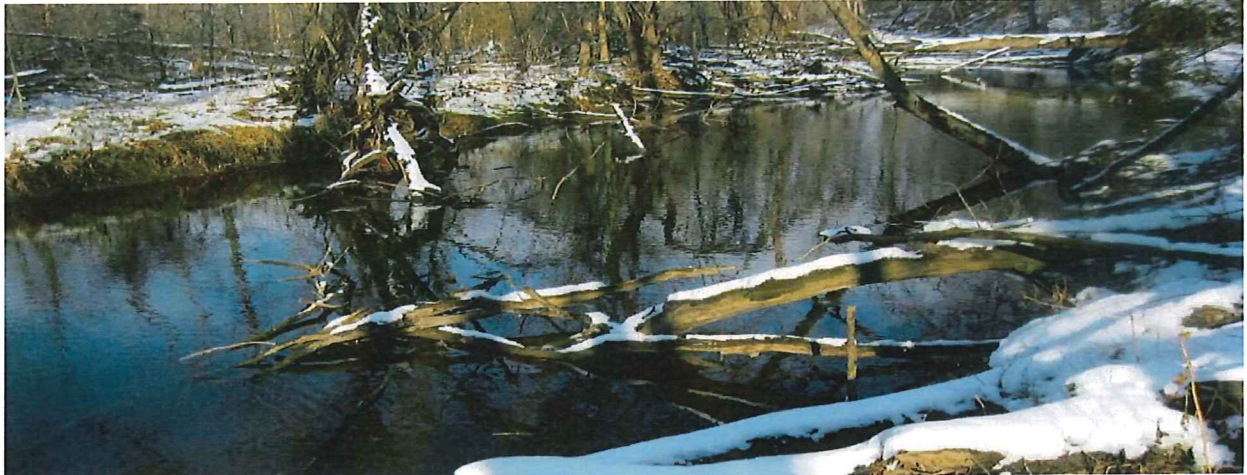
Photo 76 (Section 5 – south bank looking downstream): Trees blocking both banks of river with a small area in the middle for passage

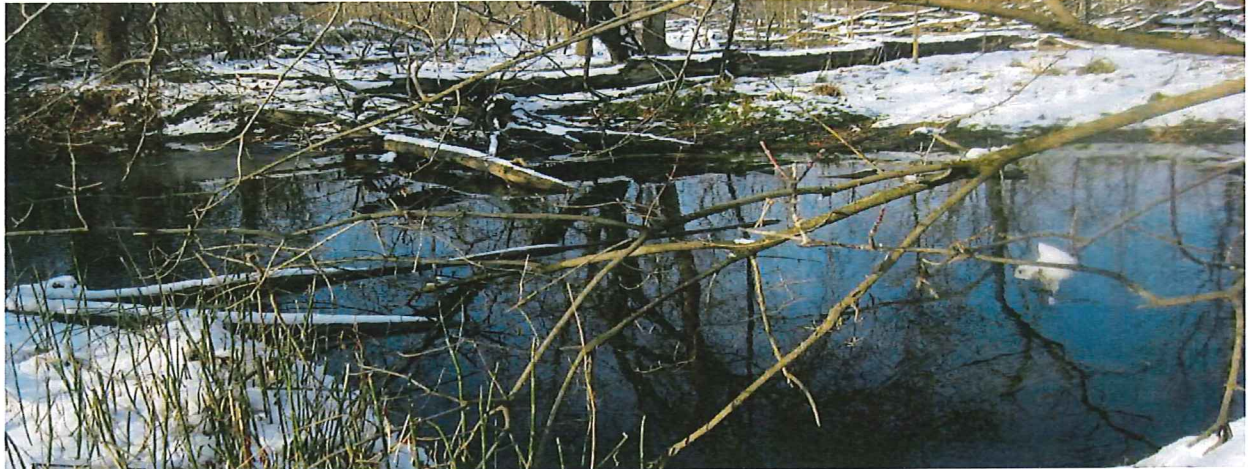
Photo 78 (Section 5 – south bank looking across river): Trees creating obstacles on both sides of river

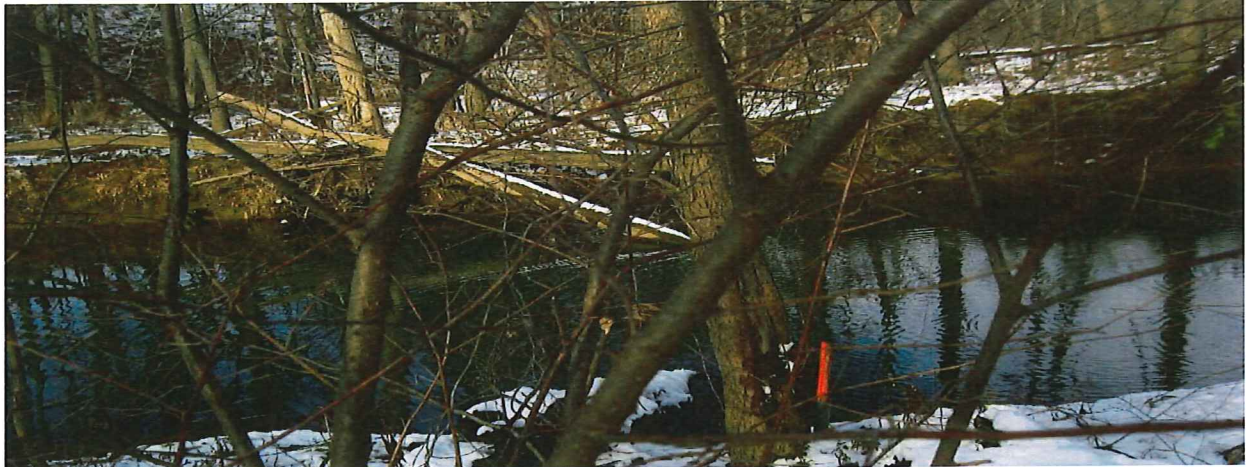
Photo 80 (Section 5 – south bank looking across river at bend): Tree on bank of river creating a partial obstruction to navigation

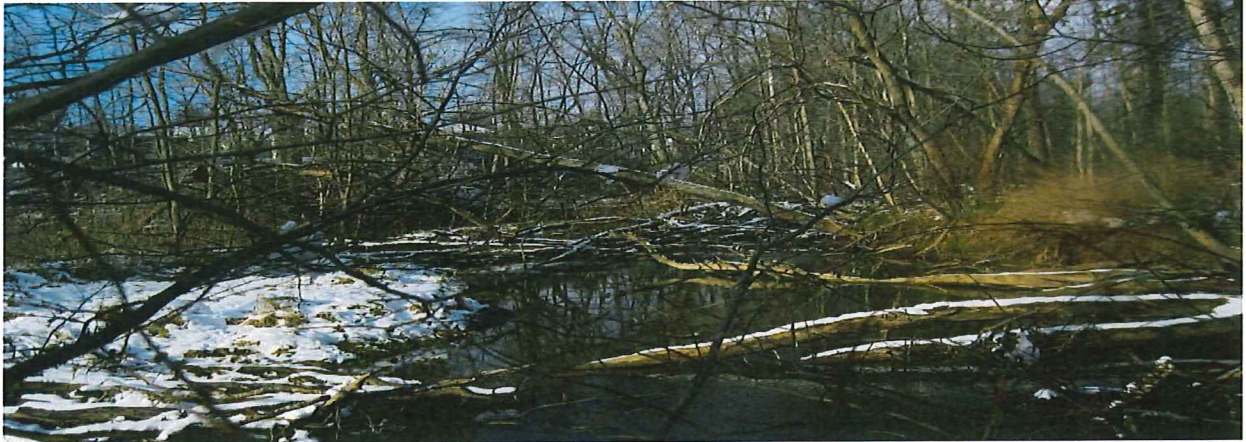
Photo 82 (Section 5 – east bank looking downstream): Several trees blocking navigation through river

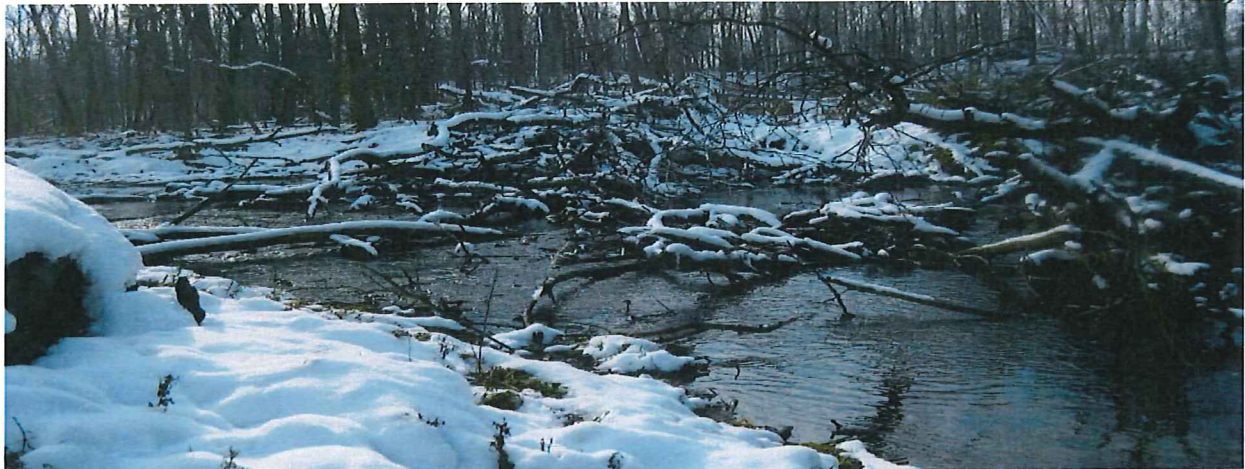
Photo 84 (Section 5 – east bank looking upstream): Groups of trees blocking navigation through bend in river

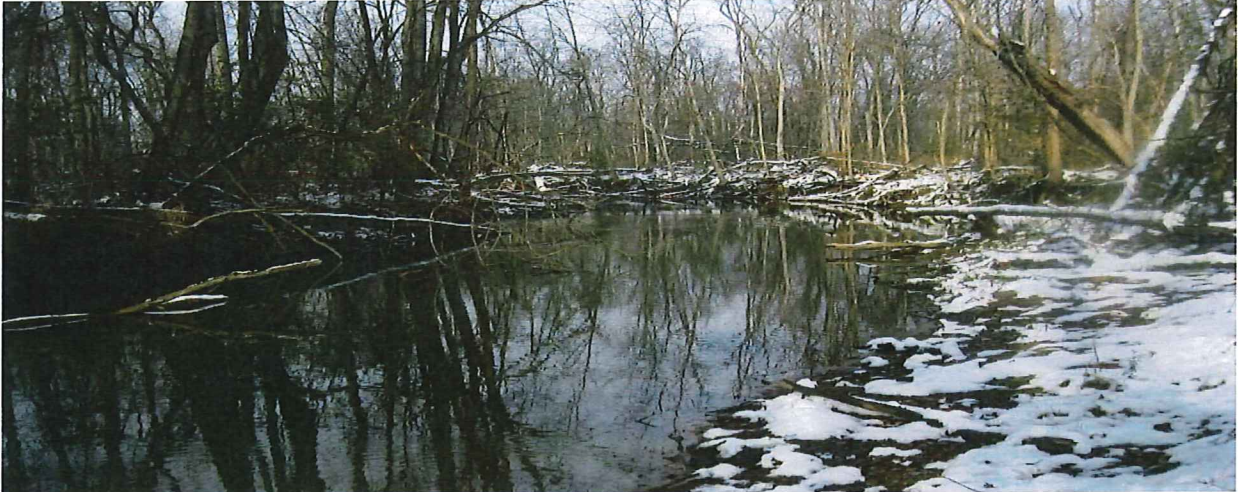
Photo 86 (Section 5 – east bank looking downstream): Tree on west bank overhanging river and tree floating near west bank of river

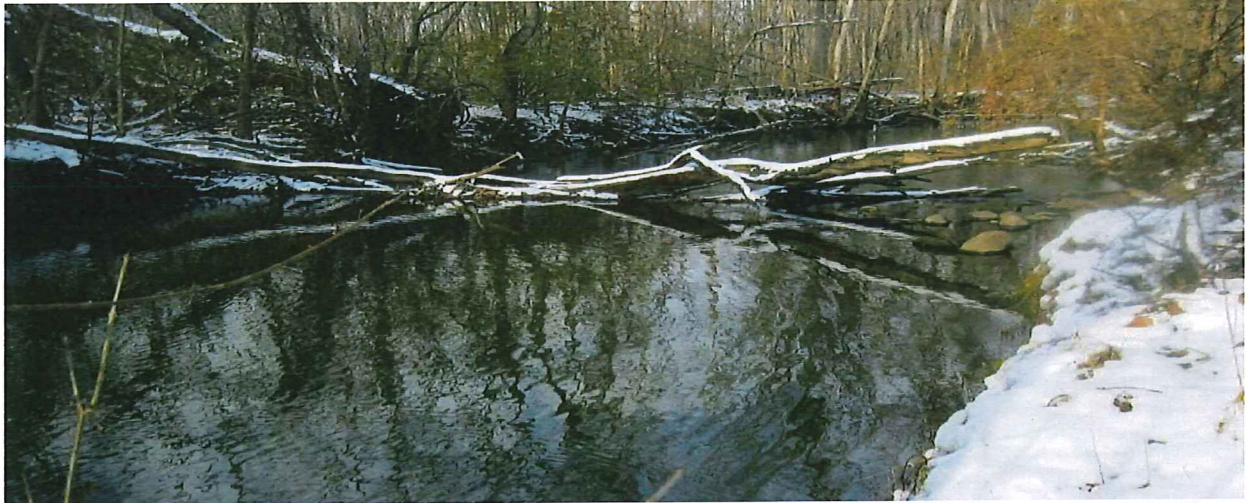
Photo 88 (Section 5 – east bank looking downstream): Tree crossing over river blocking river navigation

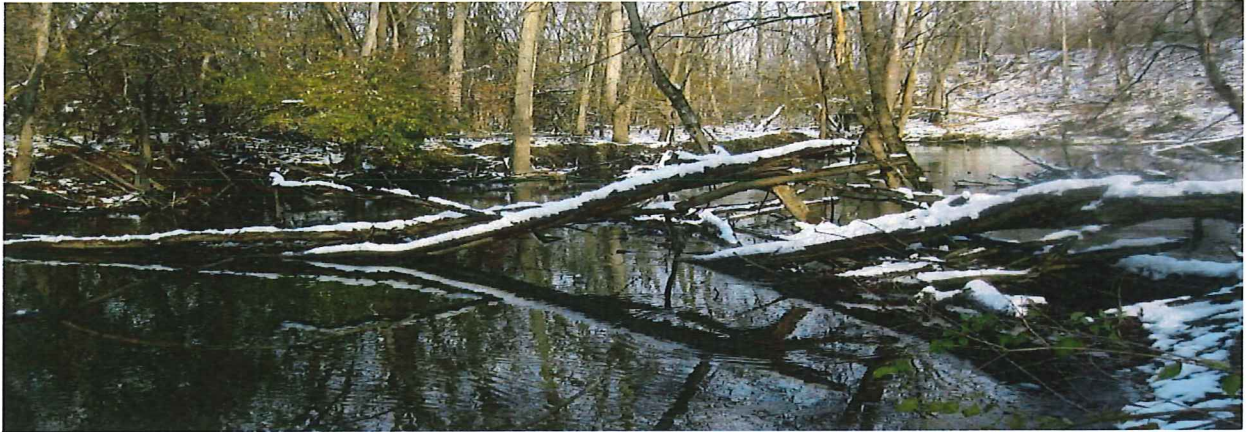
Photo 90 (Section 5 – southeast bank looking downstream): Several trees completely blocking navigation through river
