STRANDED AQUATIC ORGANISM SURVEY

**RRWC URRWRCP Impoundment Drawdown
EGLE Permit No. WRP038291 v.1
Village of Brooklyn, Jackson County, MI**

Brooklyn Impoundment Partial Drawdown Stranded Aquatic Organism Rescue and Relocation Data

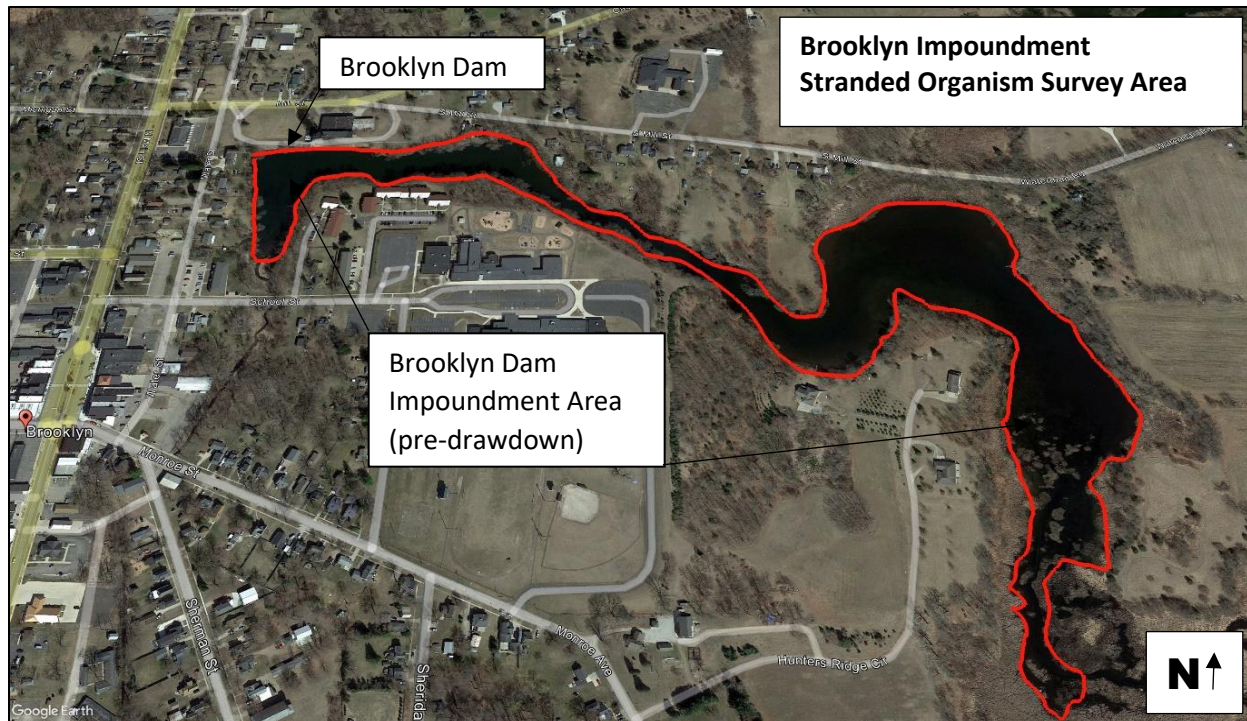
Figure 1: Stranded Aquatic Organism Survey Area Map

Type of stranded aquatic organism survey completed: Visual inspection of Brooklyn impoundment (Figure 1 below).

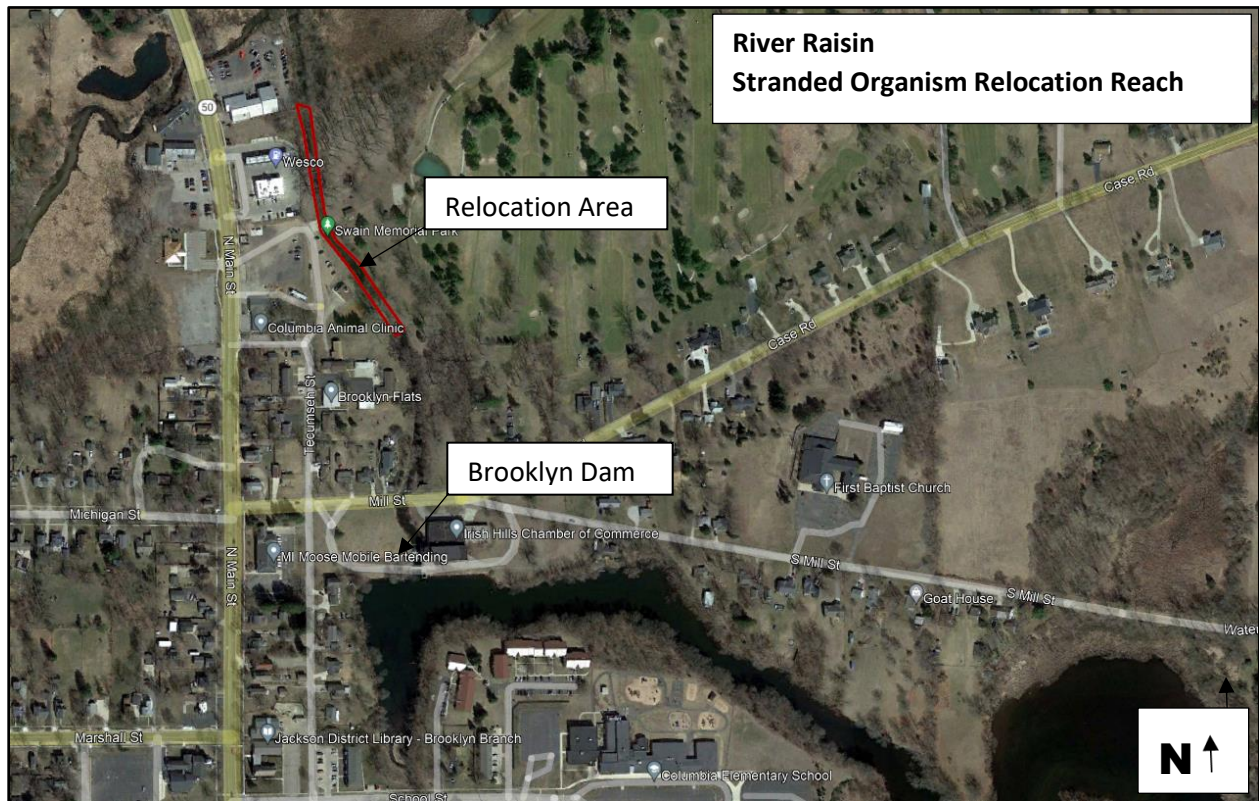
Figure 2: Relocation Reach Map – Swain Park

Stranded aquatic organisms were identified to species, measured (total length, mm) and representative photos taken. Organisms were placed into appropriate travel equipment for relocation. A staff member relocated the organisms to the relocation reach for immediate release (Figure 2).

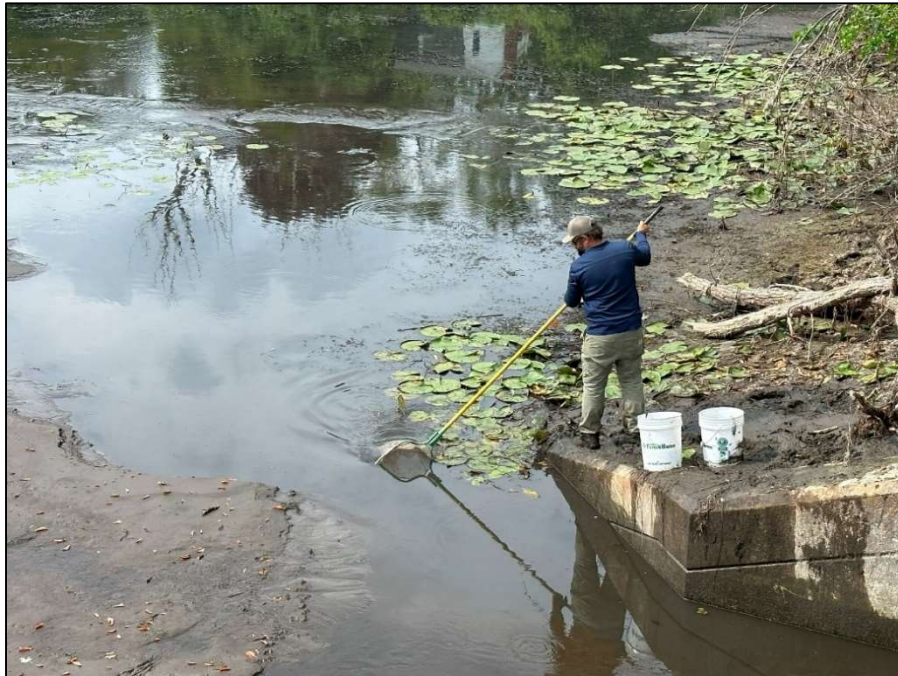
Photo 1

Niswander Staff collecting fish at upstream Brooklyn Dam abutment.
