APPENDIX D –

RIVER OBSTRUCTION INSPECTION PHOTOS

River Obstructions

Section 1: Howell Highway to Island Park

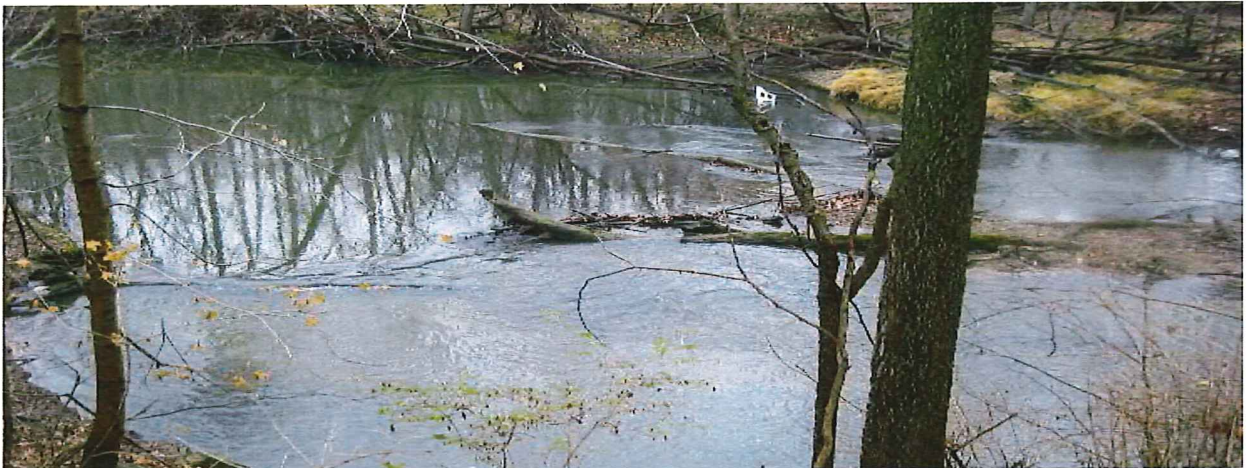
Photo 10 (Section 1 – south bank looking upstream) Trees blocking river on both sides of island

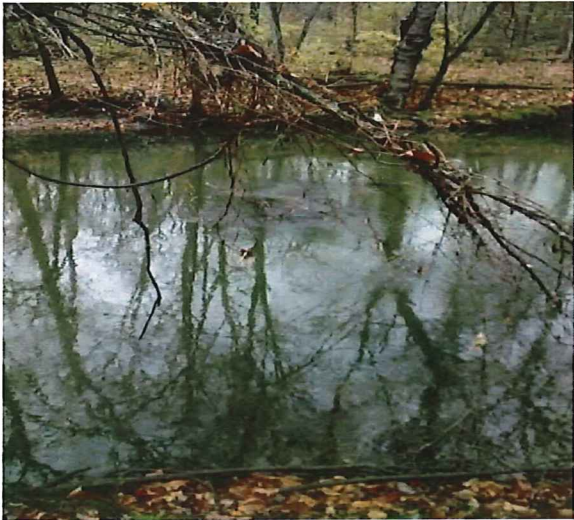
Photo 14 (Section 1 – south bank looking across river): Overhanging branch and rock in river impeding path for kayak

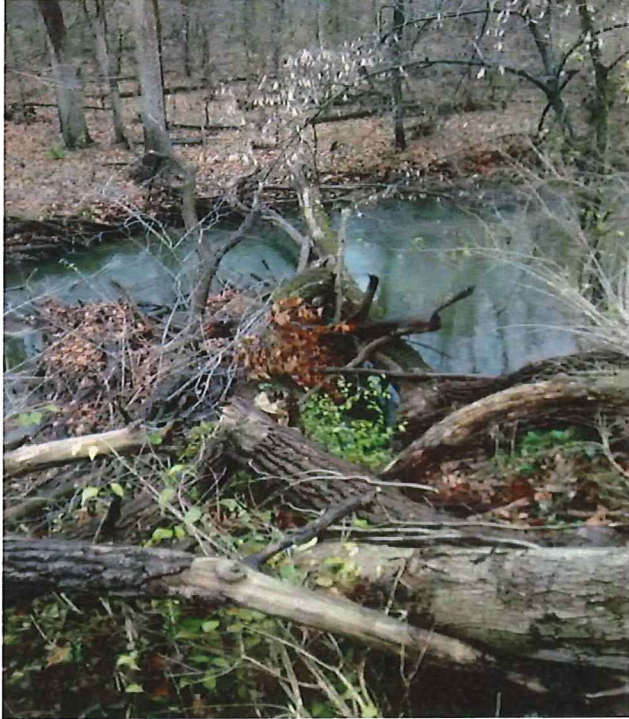
Photo 15 (Section 1 – east bank looking downstream):
Foot-diameter tree over river blocking path of kayak

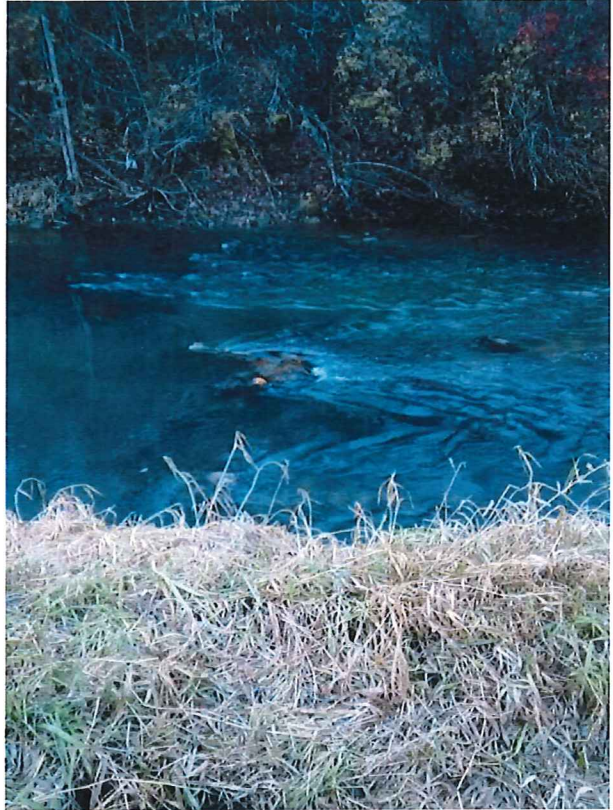
Photo 22 (Section 1 – south bank looking across river):
Boulders in river make kayak passage challenging

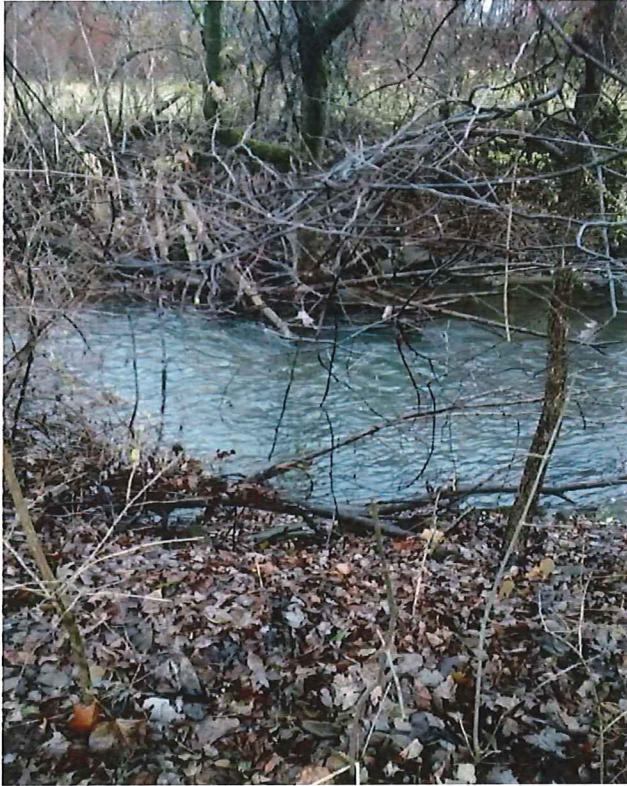
Photo 25 (Section 1 – east bank looking across river):
Tree pile on west bank of river

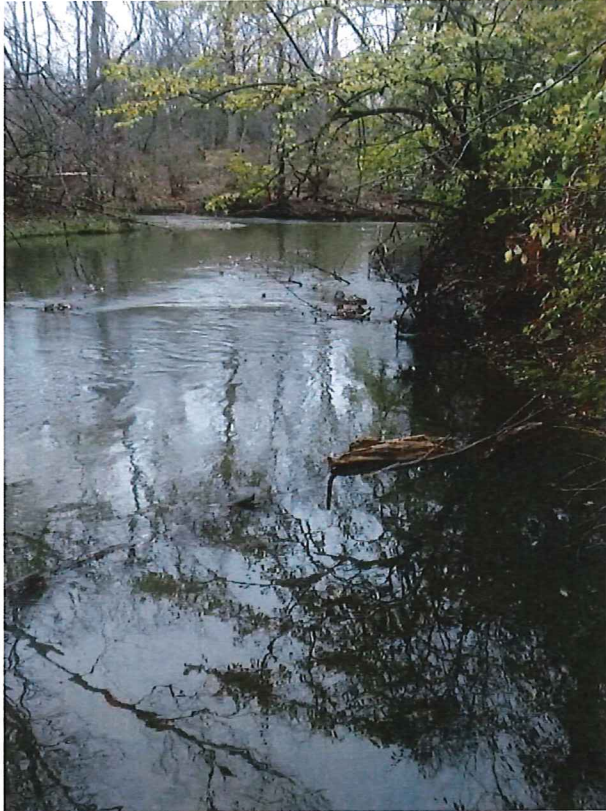
Photo 32 (Section 2 – east bank looking upstream):
Brush in water

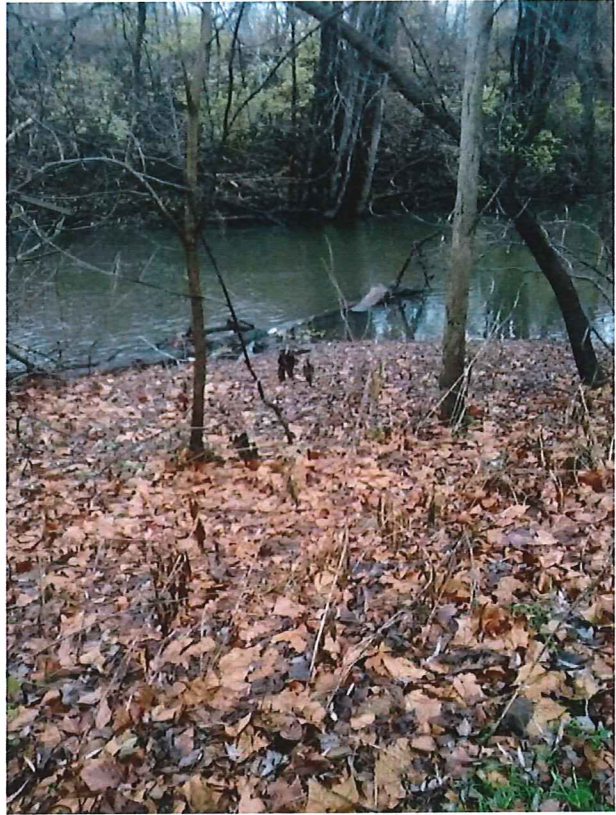
Photo 33 (Section 2 – south bank looking across river):
Down tree near bank creating obstacle for navigation

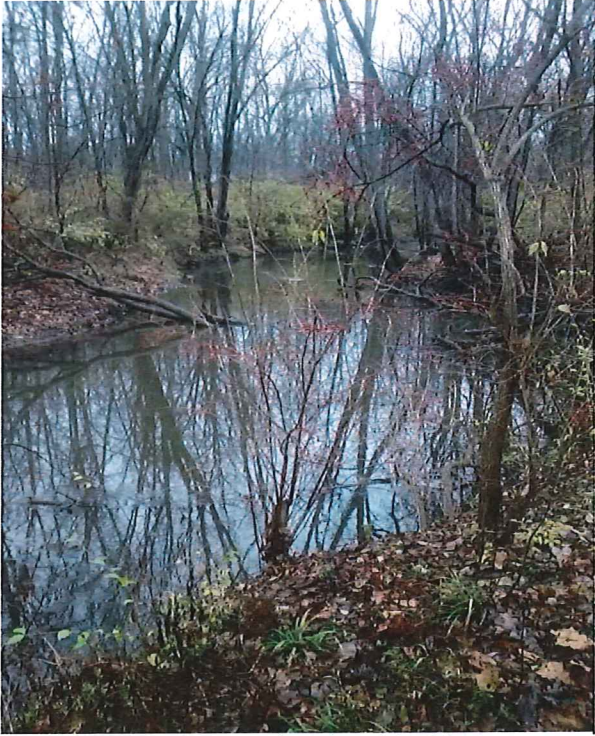
Photo 39 (Section 2 – river bend looking downstream):
Brush in water creating navigation obstacle

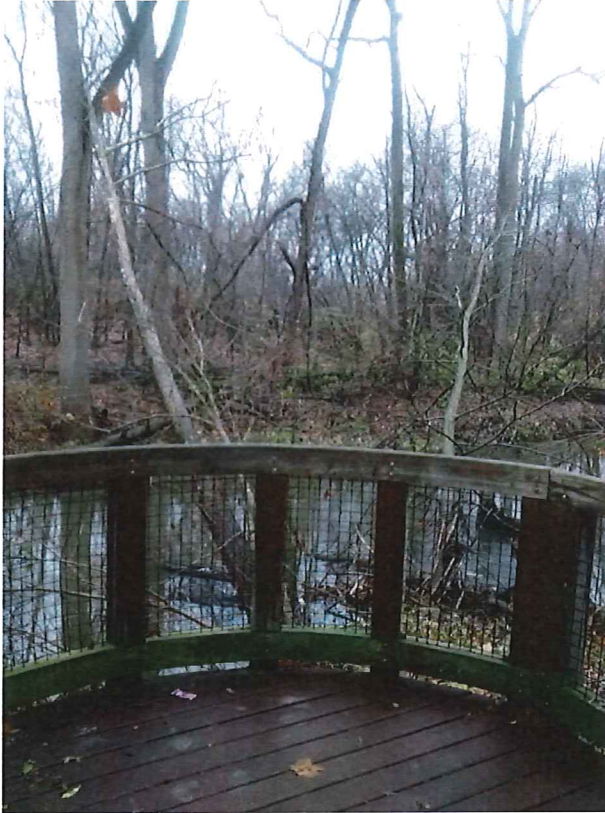
Photo 42 (Section 2 – north bank looking across river): Downed trees overhanging river

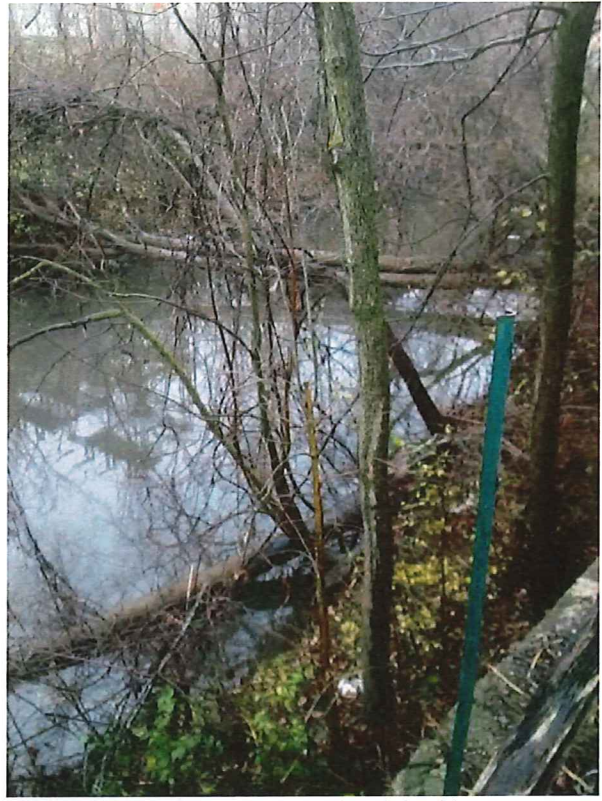
Photo 51 (Section 3 – west bank looking upstream): Downed tree blocking passage through river

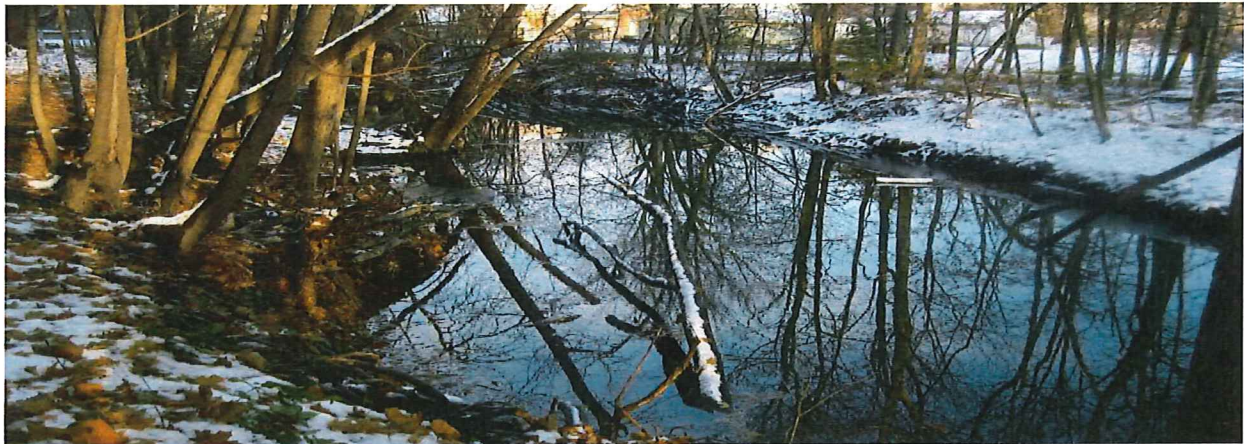
Photo 59 (Section 4 – northwest bank looking downstream): Tree branch near bank of river

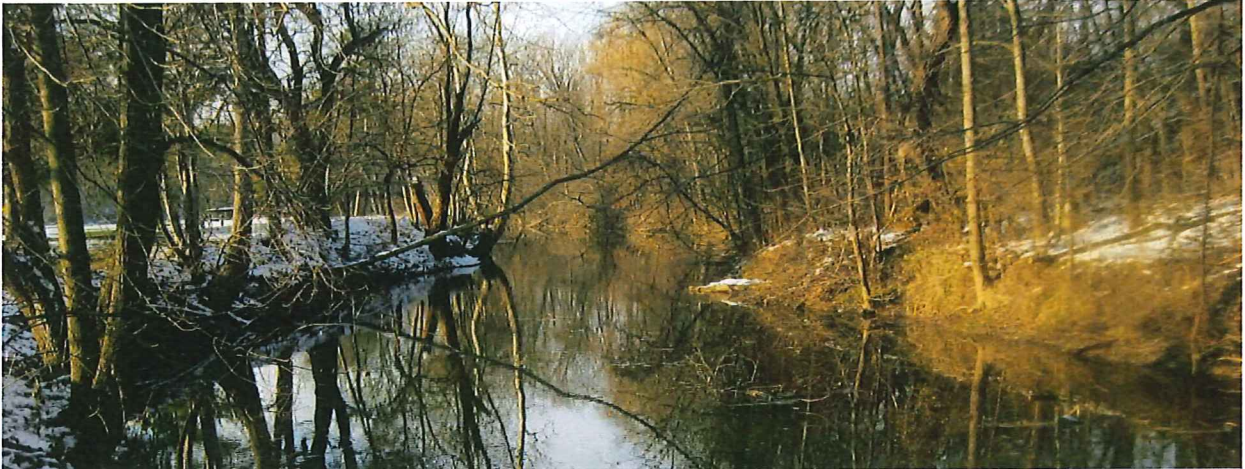
Photo 61 (Section 4 – west bank looking downstream): Tree overhanging river that could eventually fall into river

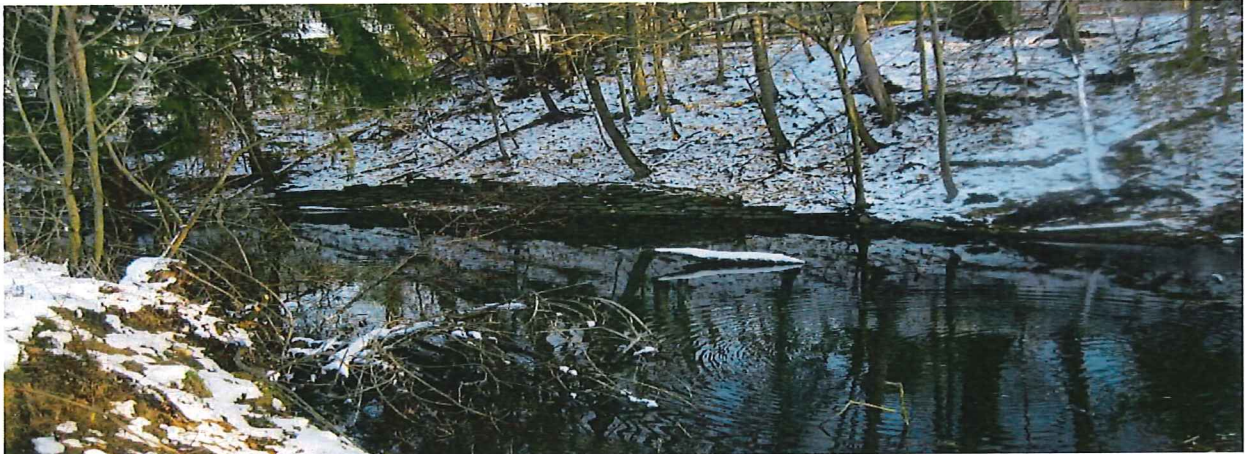
Photo 65 (Section 4 – west bank looking downstream): Tree brush obstructing bank and middle of river

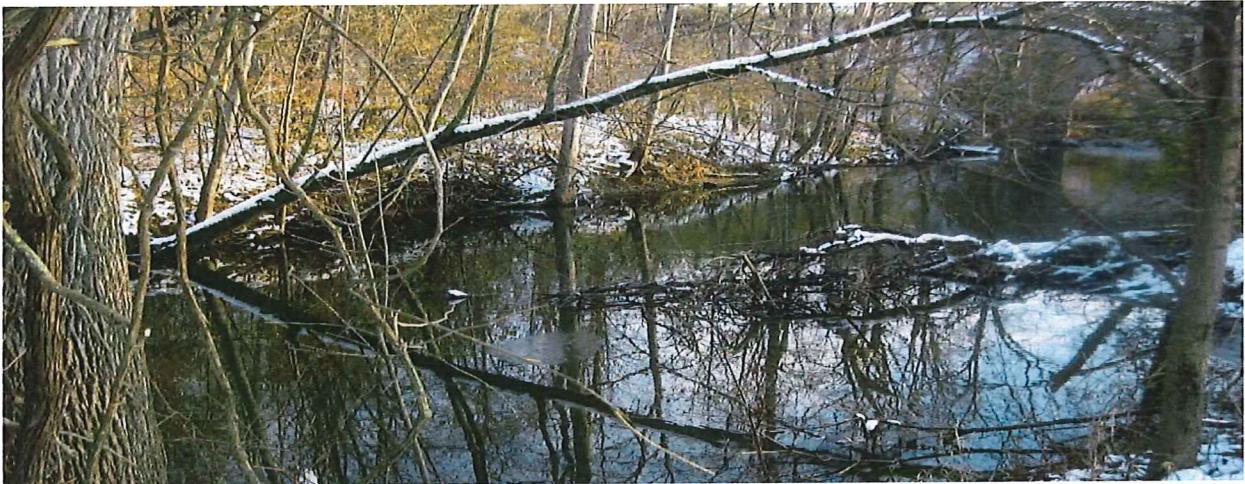
Photo 67 (Section 4 – west bank looking upstream): Tree on west bank blocking navigation through half of river and tree on east bank hanging over river

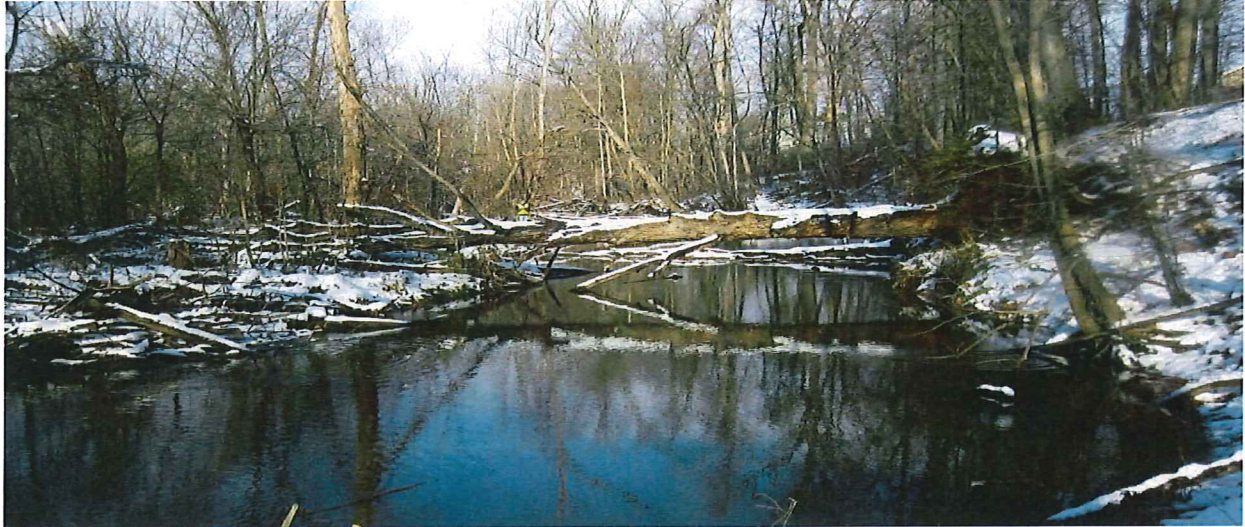
Photo 75 (Section 5 – east bank looking downstream): Large (2-foot diameter) tree resting over river

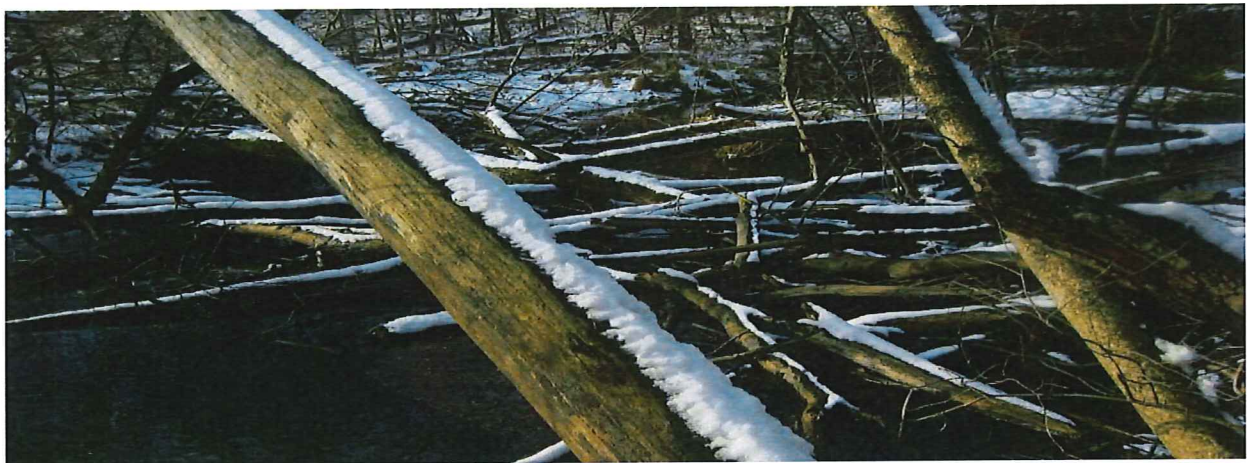
Photo 81 (Section 5 – east bank looking downstream): Pile of tree branches blocking passage

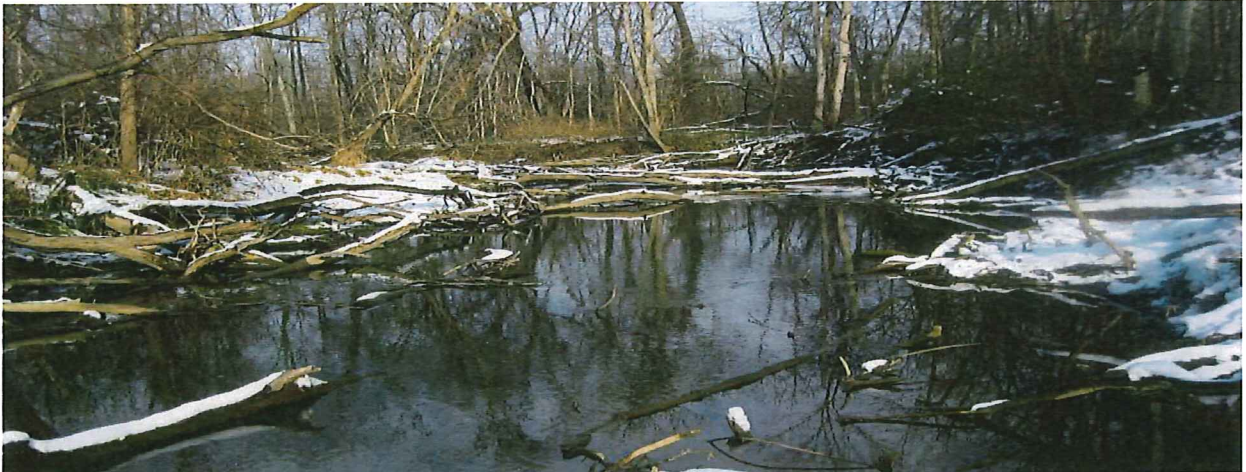
Photo 83 (Section 5 – east bank looking downstream): Several branches impeding navigation through river

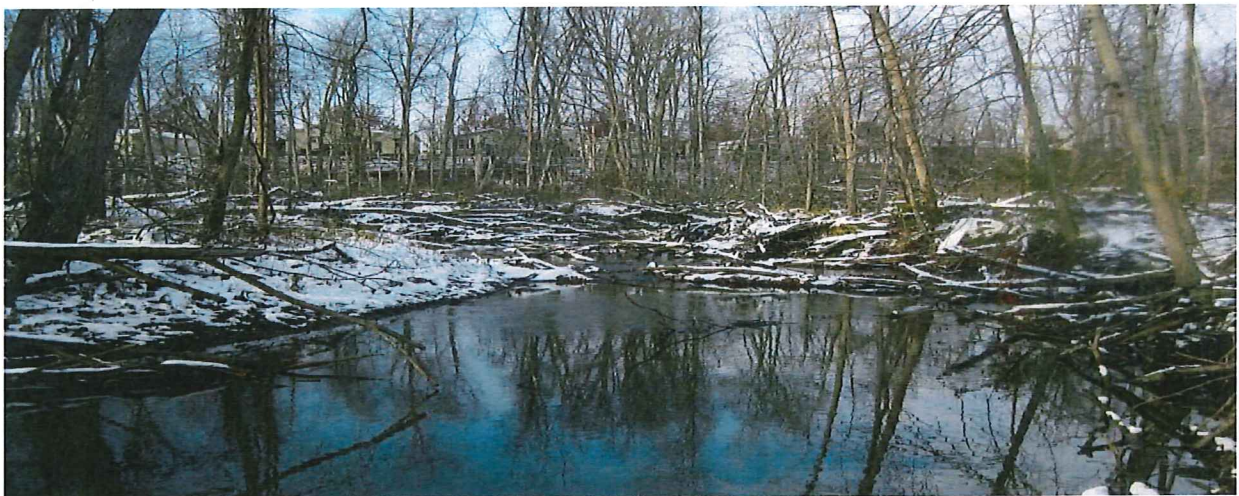
Photo 85 (Section 5 – east bank looking downstream): Several trees impeding river navigation

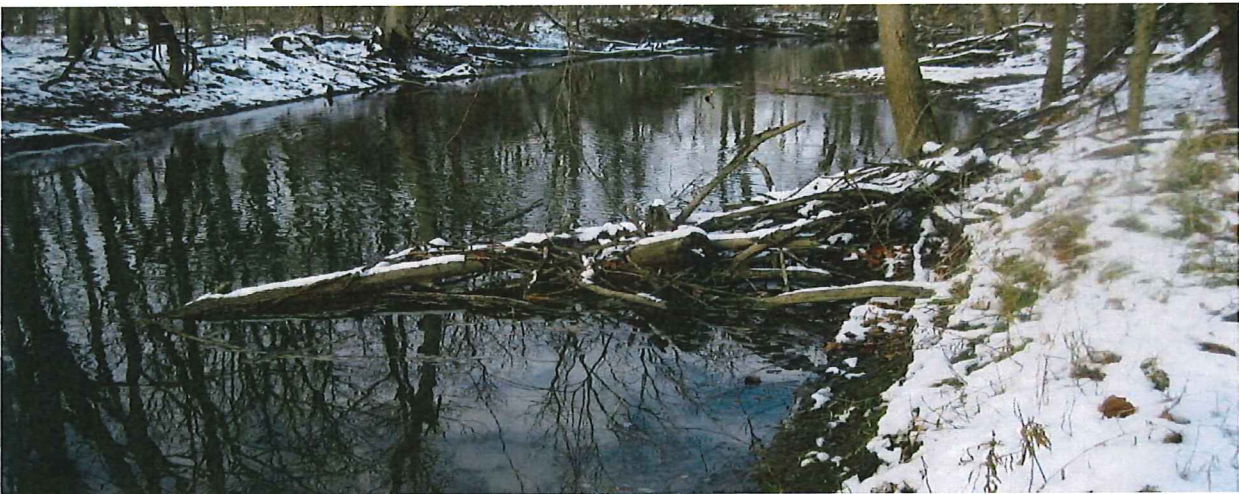
Photo 87 (Section 5 – east bank looking downstream): Tree brush on east bank entering river

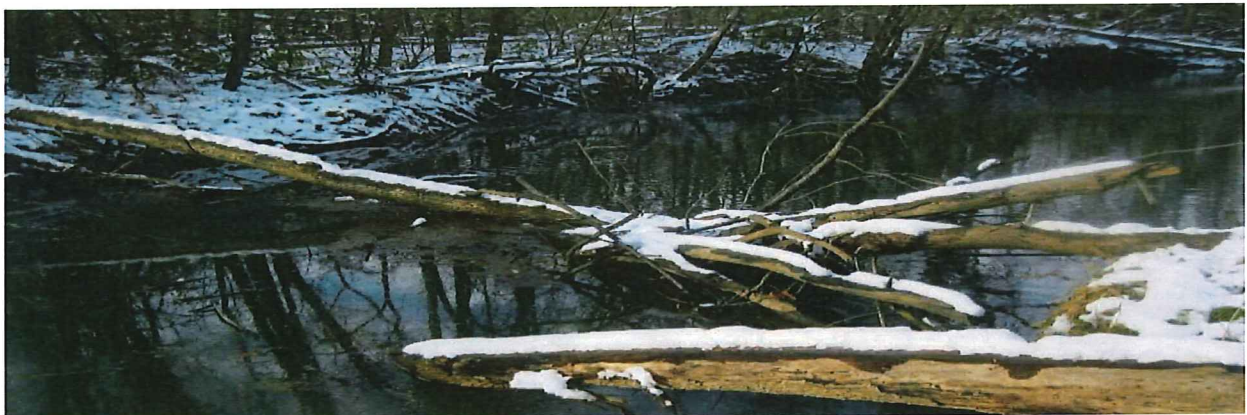
Photo 89 (Section 5 – east bank looking downstream): Downed tree blocking river navigation

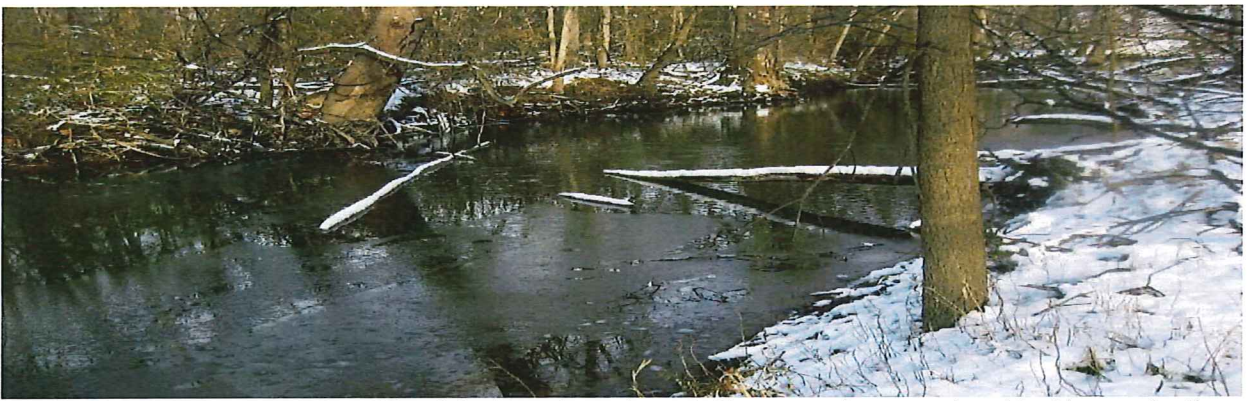
Photo 91 (Section 5 – southeast bank looking downstream): Tree crossing over river blocking navigation through river

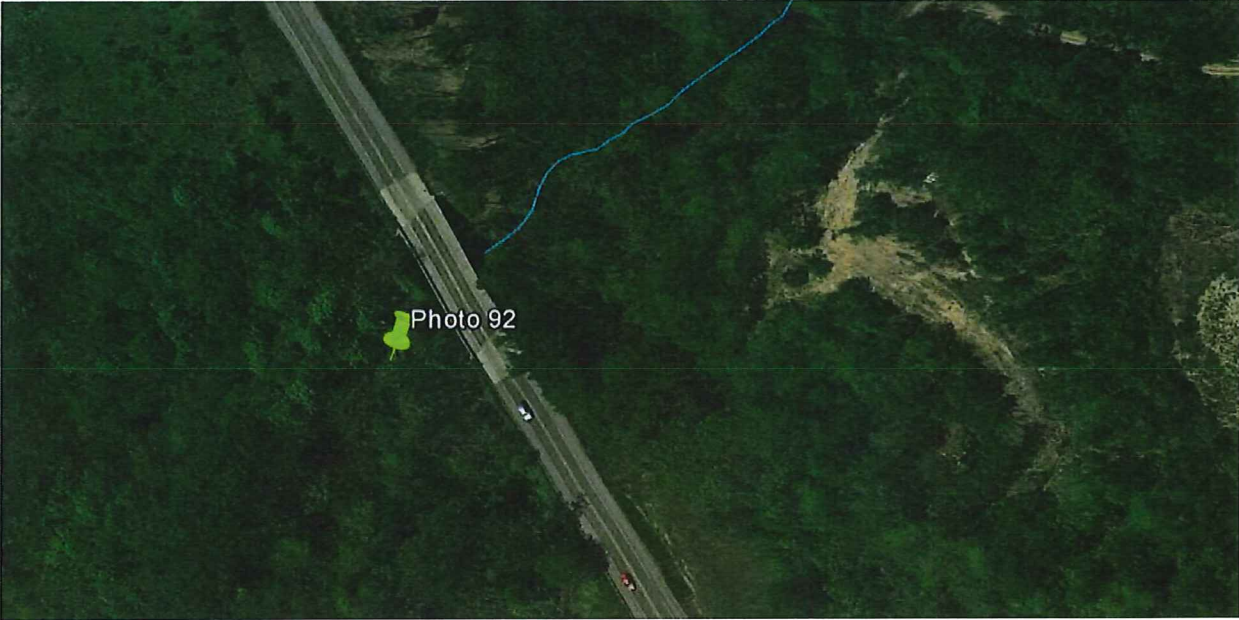
Photo 92 (Section 5 – southeast bank looking upstream): Tree blocking navigation through river past Highway 223 Bridge
